CITATION: *Inquest into the death of Peter John Bonnell*
[2018] NTLC 002

CATCHWORDS: **Collision by motorcycle rider with temporary traffic control devices, rider impairment, failure to install traffic control devices in accordance with Australian Standard, report to DPP**

PETER JOHN BONNELL
ON 30 APRIL 2016
AT TIGER BRENNAN DRIVE

FINDINGS

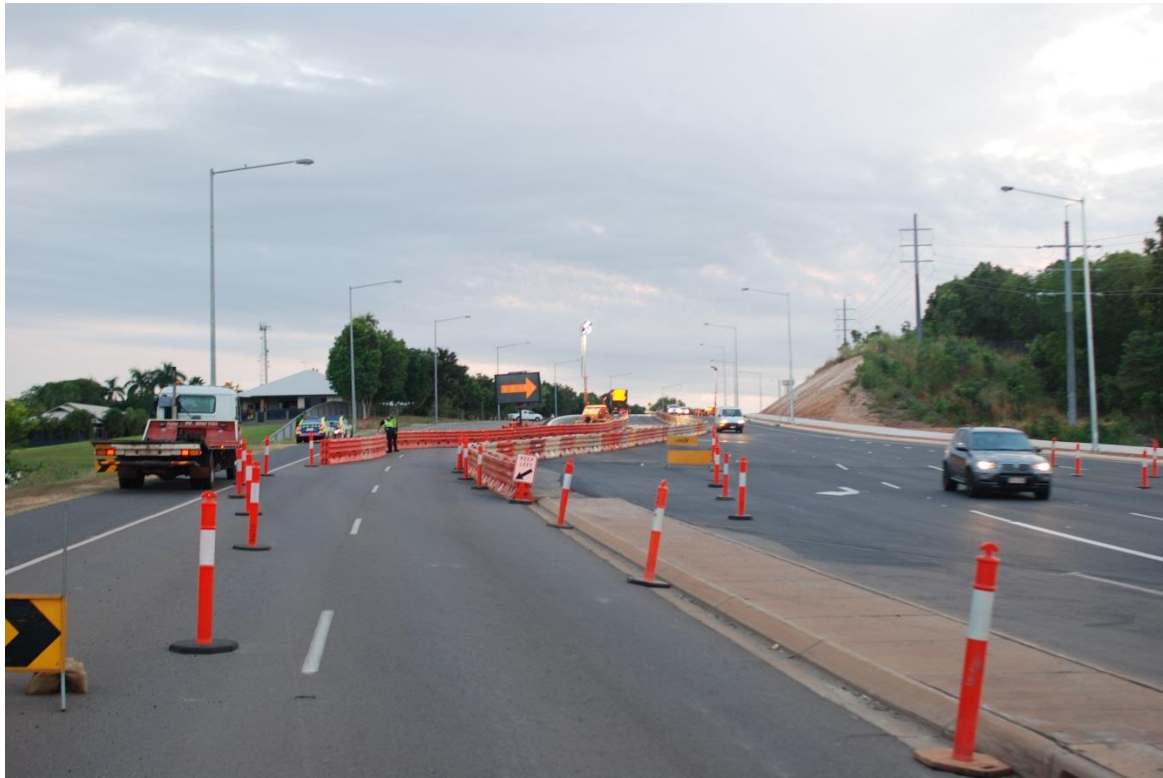
23. Not doing so, was non-compliant with AS1742.3 clause 3.9.4(b):

“If existing markings are not appropriate or are potentially misleading, they should be removed and replaced by more suitable markings ...”

“The presence of the dividing lane broken centre line creates potential night time directional confusion for traffic, as it continues into and under the barrier crossover configuration. Drivers use lane lines as a primary road direction delineation source, temporary lane direction changes such as the crossover should be setup to mitigate the potential for driver confusion.”

26. The following picture taken just after dawn on the morning of the crash shows the direction of the white line into the barriers.

“It [the white line] should have been rubbed out or blacked out and retroreflectivity stickers or cat’s eyes ... used to create a delineation for the line work or repaint it so that it was available for delineation.”²

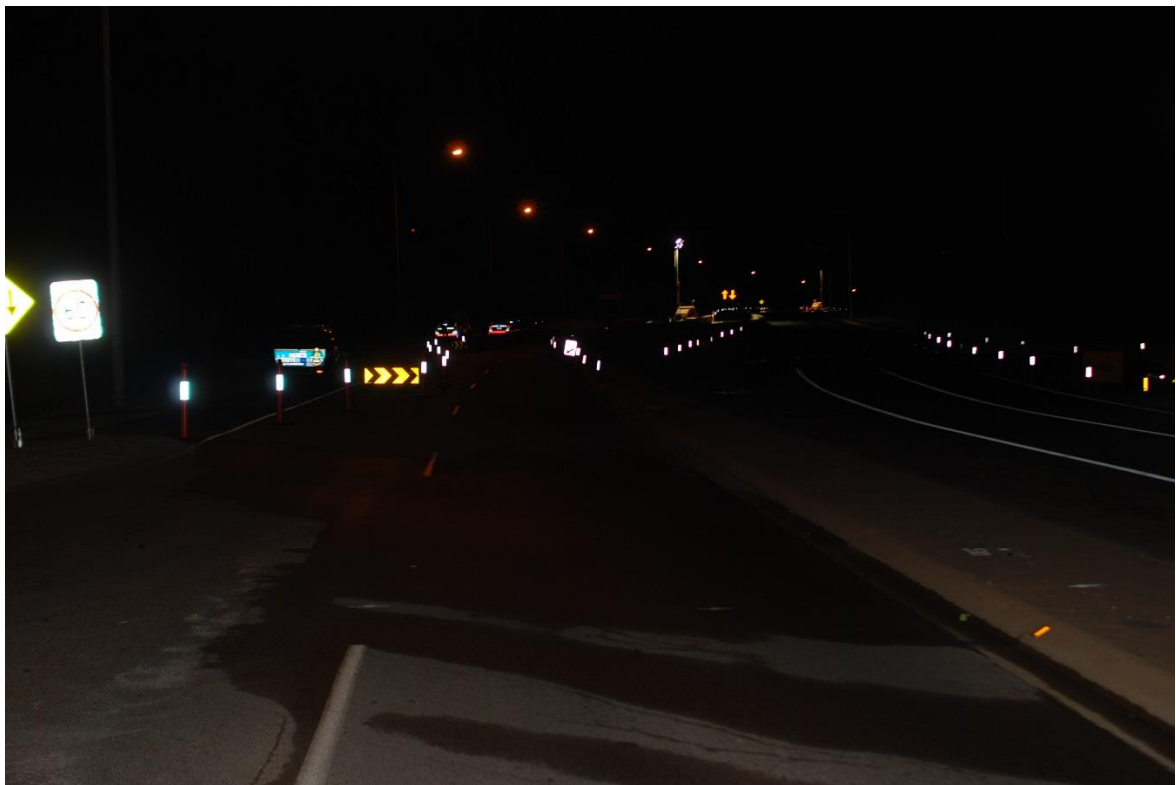
27. The following picture was taken on the night Mr Bonnell crashed into the barrier.

“The above photograph was taken on the night of the incident, while it is poor quality and not a true representation of available ambient light or headlight illumination, it does highlight the deficiency of retroreflective delineation at the start of the right curve formed by the lateral shift crossover.”

29. He said there should have been reflective bollards on each side of the road inside the barriers. The approved Traffic Control Diagram (TCD) had retroreflective bollards on each side for the whole of the crossover. Without those the setup could not be compliant with AS1742.3 clause 4.14.6(d):

“At crossovers, the temporary diversion through the median shall be delineated with traffic cones or bollards at 2 metre spacing.”

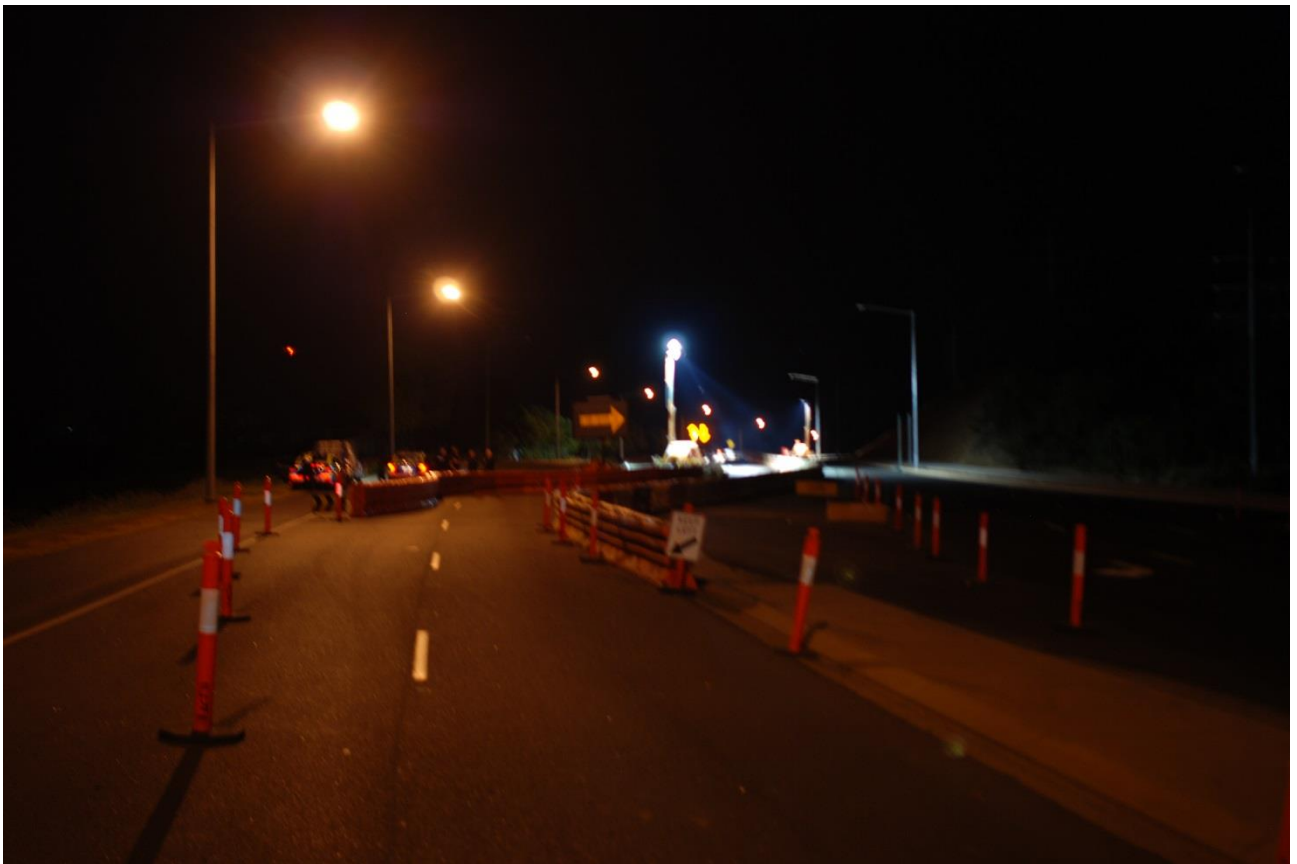
30. He noted also that the flashing illuminated arrow was not aligned to the approach to the curve.

“The above time exposure photograph provides a more realistic view of the lighting conditions present at the time of the incident, with the

trailer-mounted flashing directional arrow now visible, although it is misaligned with the approaching travel lane and may be camouflaged to some degree against the lighting plant background glare”

“...lighting plants by their nature are very bright, glaring lights which are designed to light up a small - a relatively small radius area like a work site for localised conditions. That can cause issues particularly when there’s barriers that are also there to create shade in the light - bright light areas and then shadier area ...So with these lighting plants it’s quite critical where you locate them so that you don’t cause issues with driver’s vision, because human eyesight’s such that if you look at a glary light like that, that you look away. If something’s in the shadow it takes a while to adjust to those different lighting conditions between a bright light and a - a less bright light, so to speak.”³

33. It is likely the side of the barriers facing Mr Bonnell as he approached the crossover were in relative shadow due to the glare of the lighting plant.

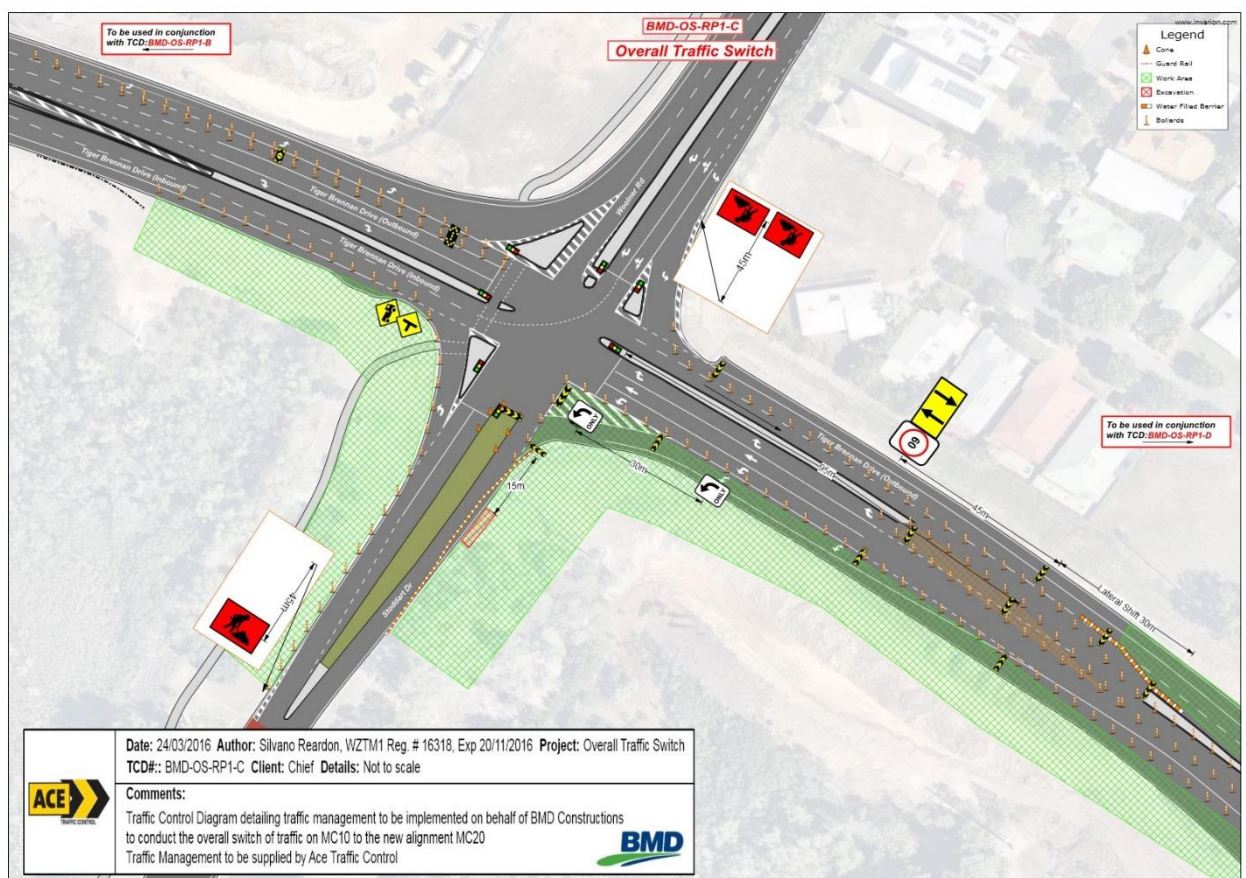
Diagram 1 showing approved TCD for Woolmer Road intersection with retroreflective bollards delineating the intended path of the traffic at commencement of crossover (right lower part of diagram)

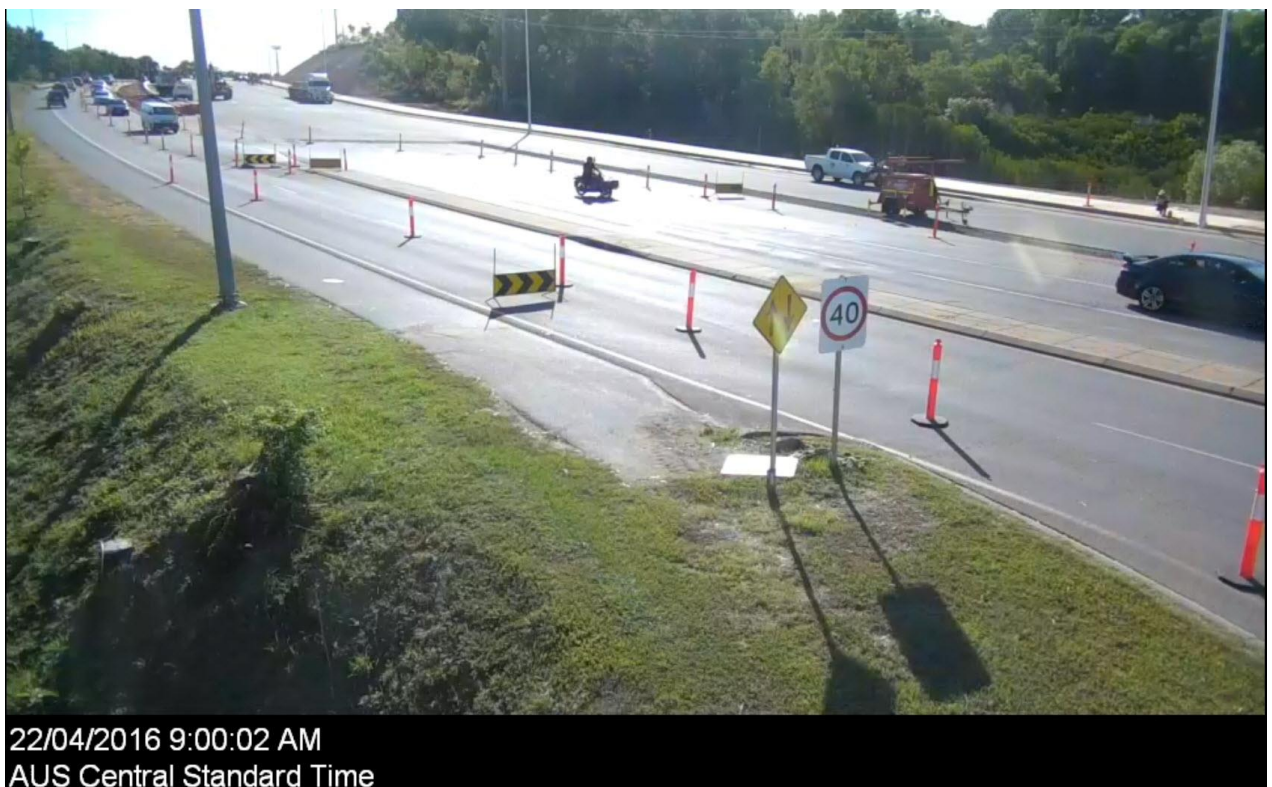
73. Looking outbound from the Woolner Road intersection before the Switch was set up, traffic control was as depicted in the photograph below.

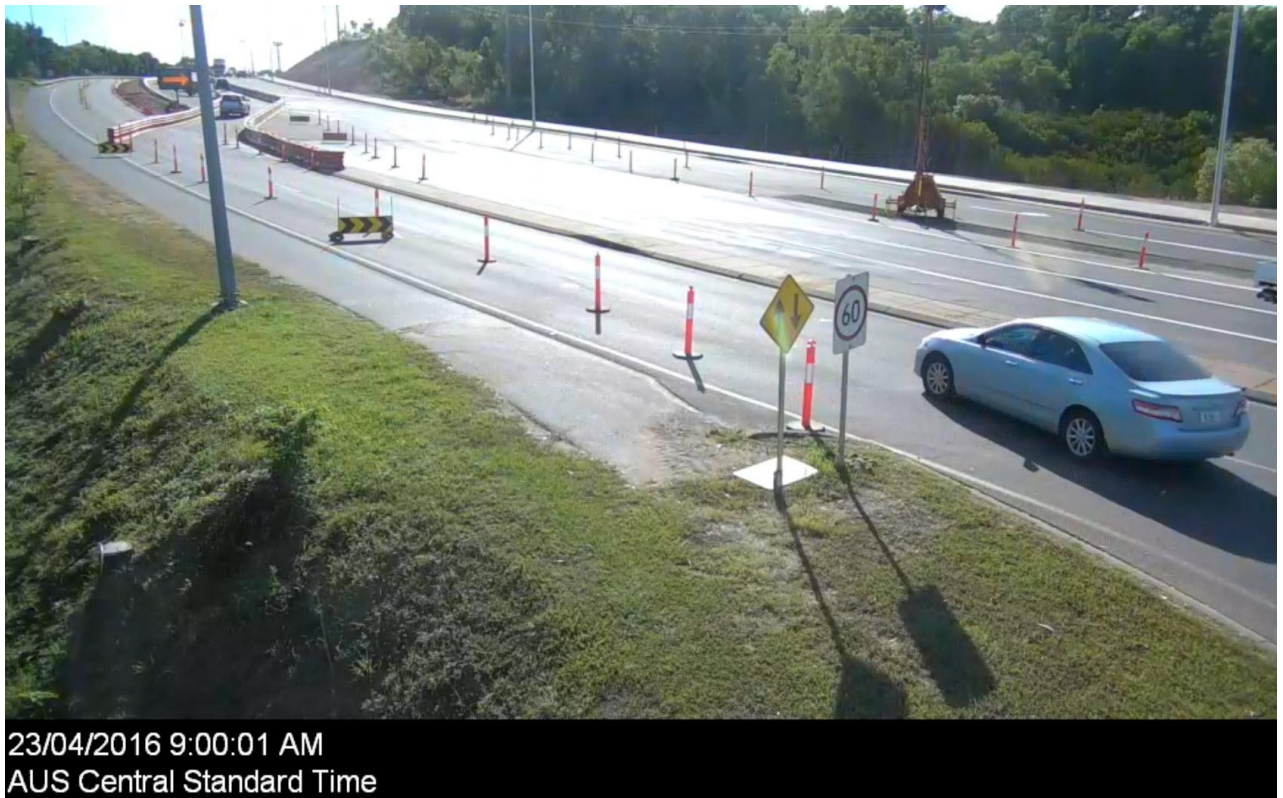
74. The next morning it had been changed as depicted in the following photograph.

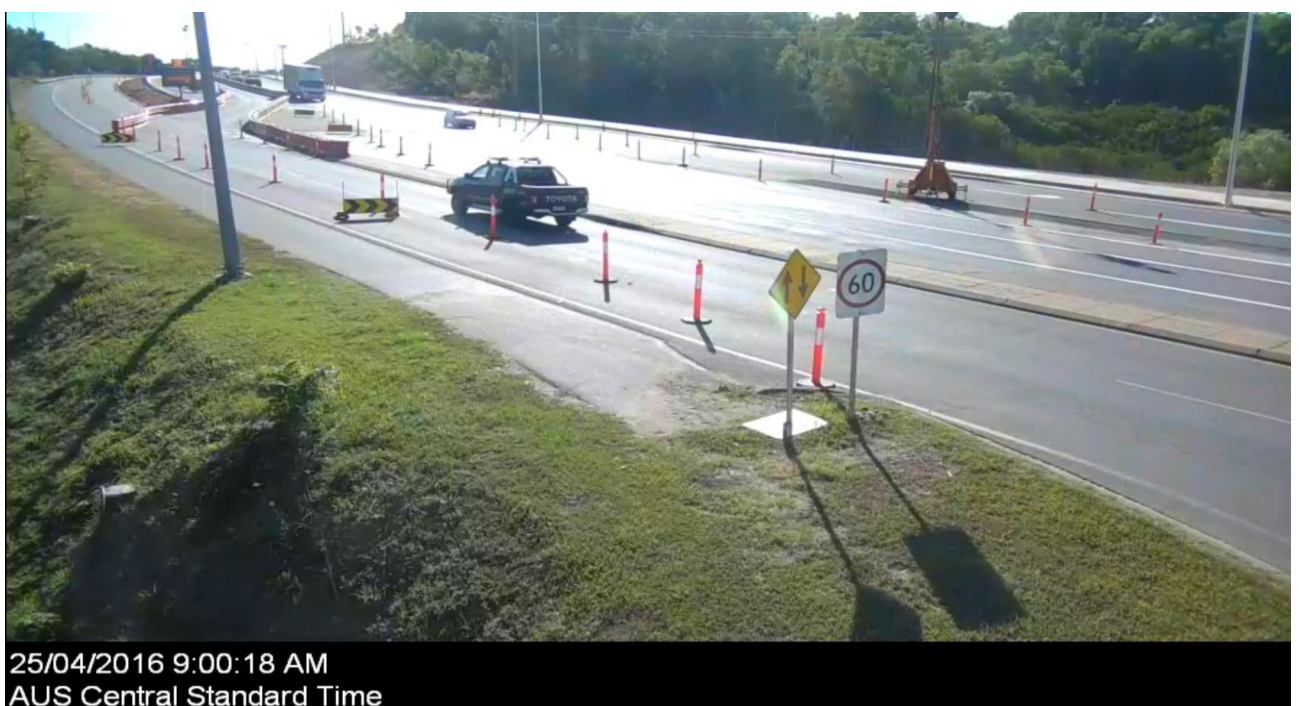
On the morning of 25 April 2016 the view showed that some of the interlocking barriers on the left had been moved out of alignment.

76. It is not known how that happened. The movement of the barriers was not known to BMD or DIPL and there appears to be no record of that being noticed during any inspection and audit. It is however likely that the movement occurred due to the barrier being hit by a vehicle.
77. Four days later correction was made. There is no note of who put the barriers back into alignment. DIPL and BMD said they had no knowledge of that either.

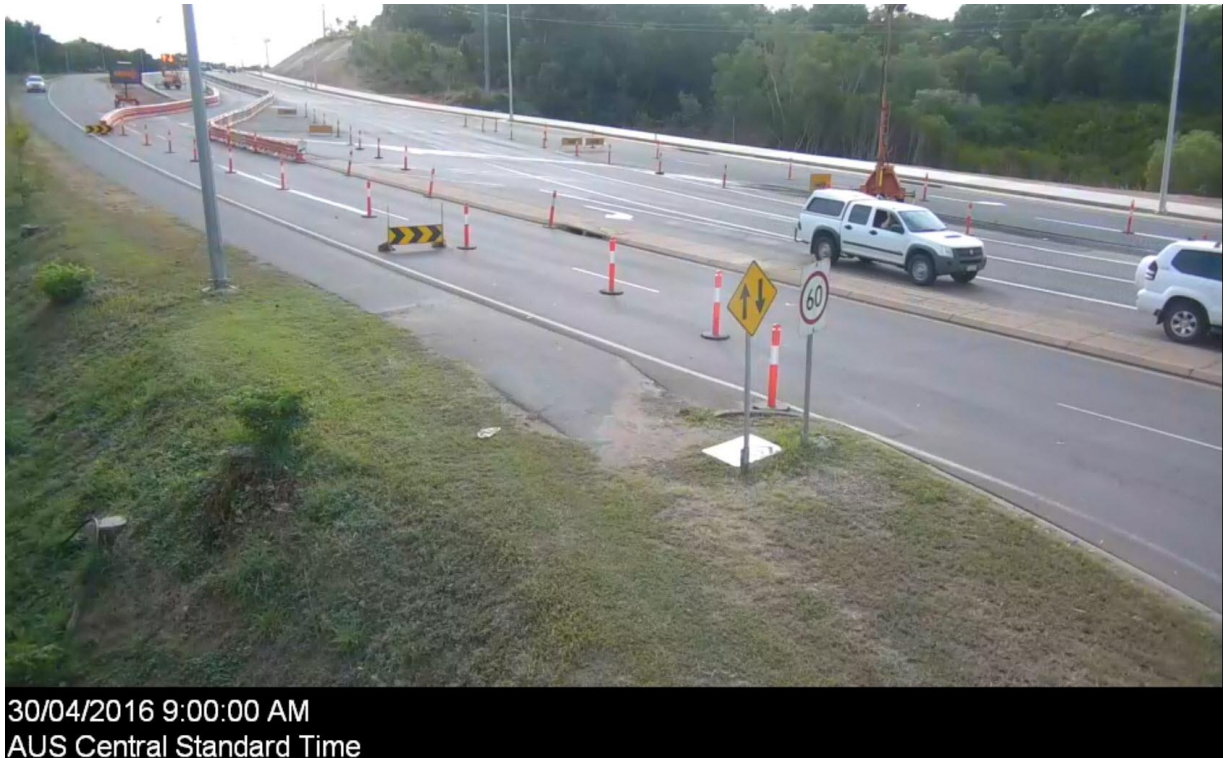
78. After the deceased struck the barriers they were pushed out of alignment again, as depicted in the photograph below.

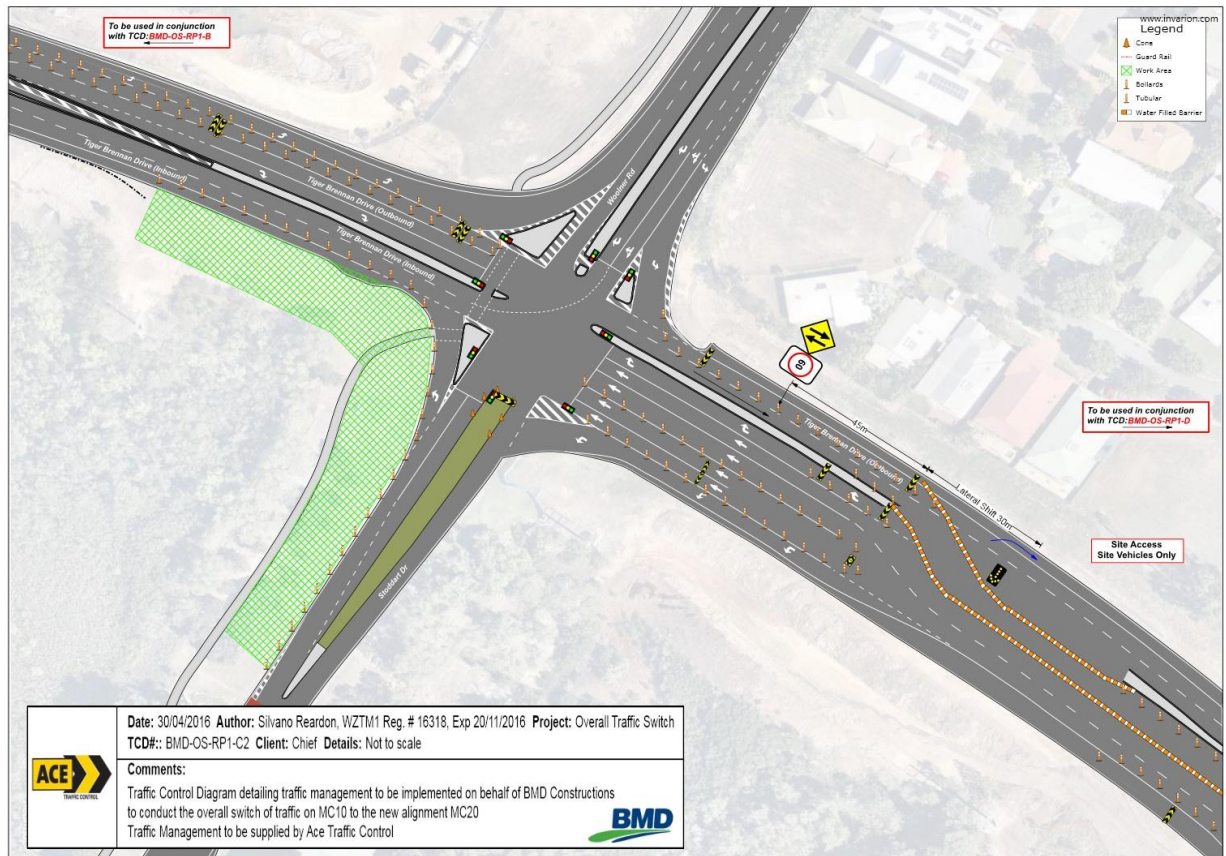
- Substitution of the compliant retroreflective bollards with non-reflective barrier channelization.
- Substitution of on-road lateral shift hazard markers with a trailer mounted flashing directional arrow.
- Changes to the lateral shift configuration creating a substandard 60km/h speed zone curve radius.

Diagram 2 showing TCD prepared on 30 April 2016 illustrating actual setup

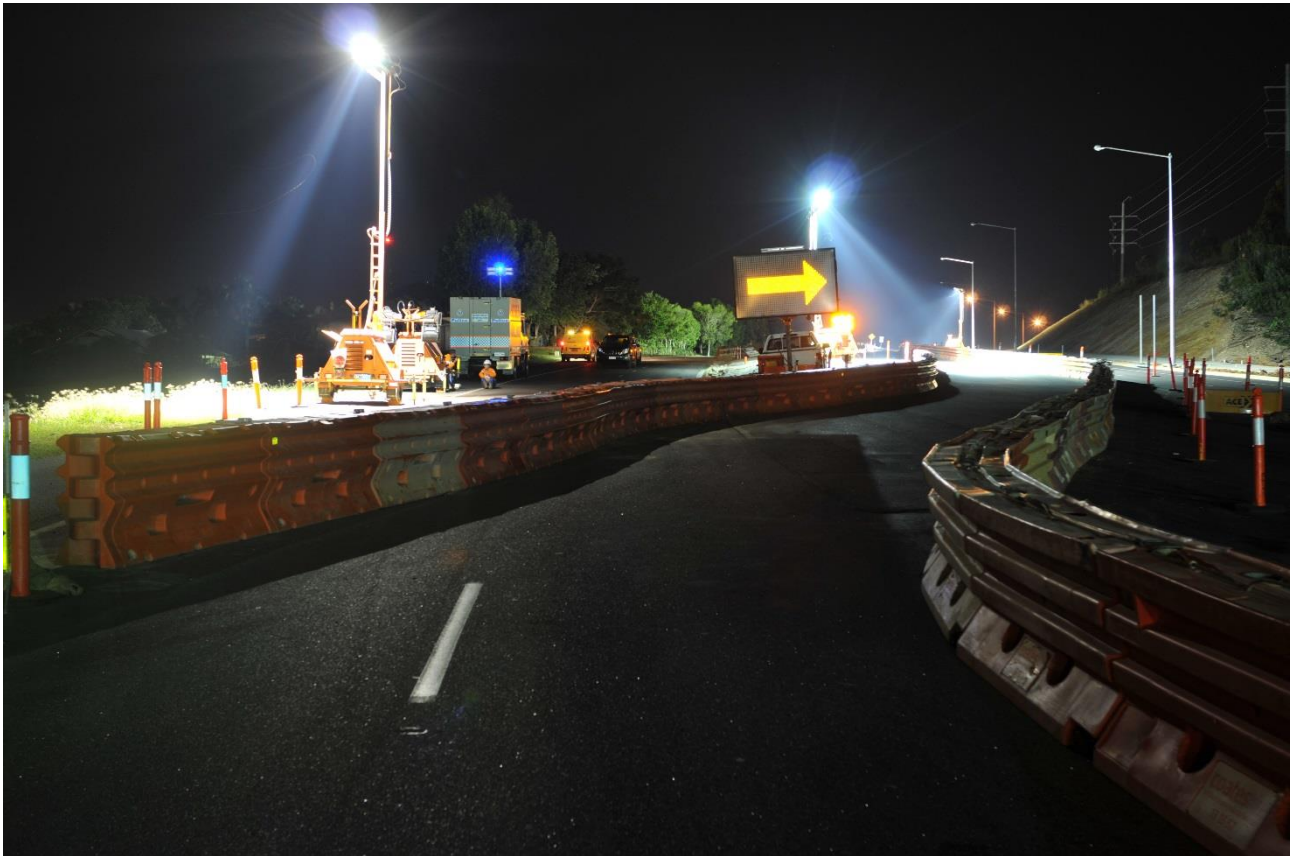
Photo 8 showing reflectors on barriers (taken a week later)

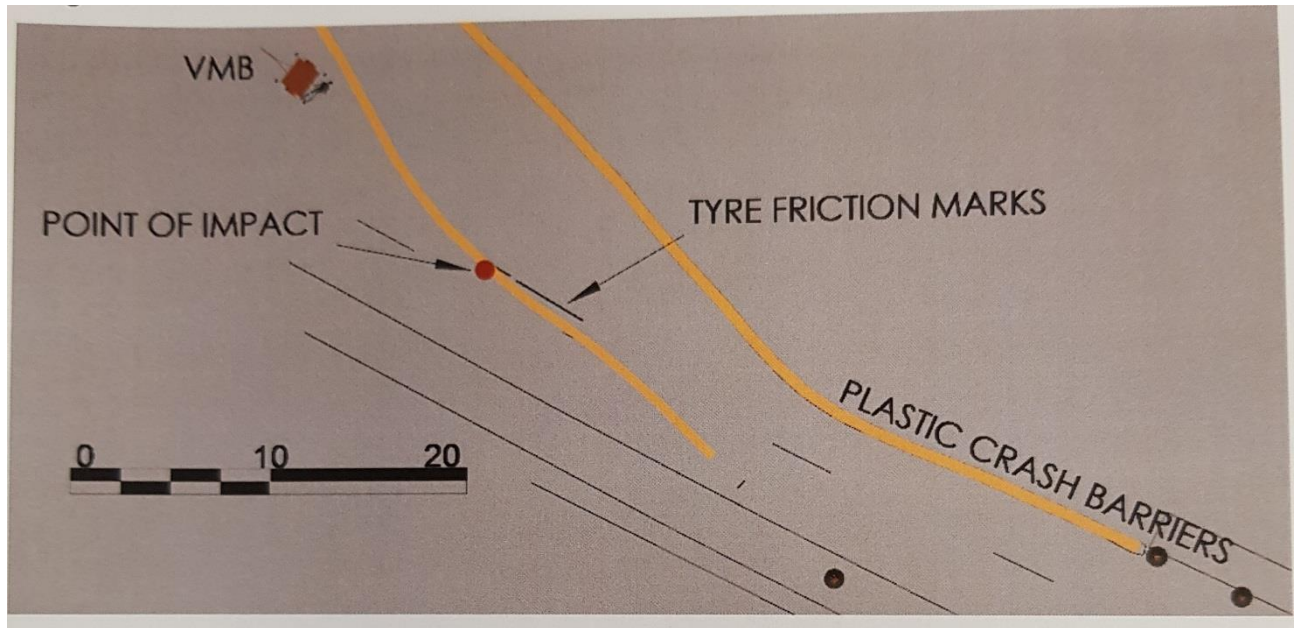
Diagram 3 showing the crash barriers before impact as well as tyre friction marks, position of the VMB (illuminated flashing arrow on trailer) and position where the deceased was located after impact

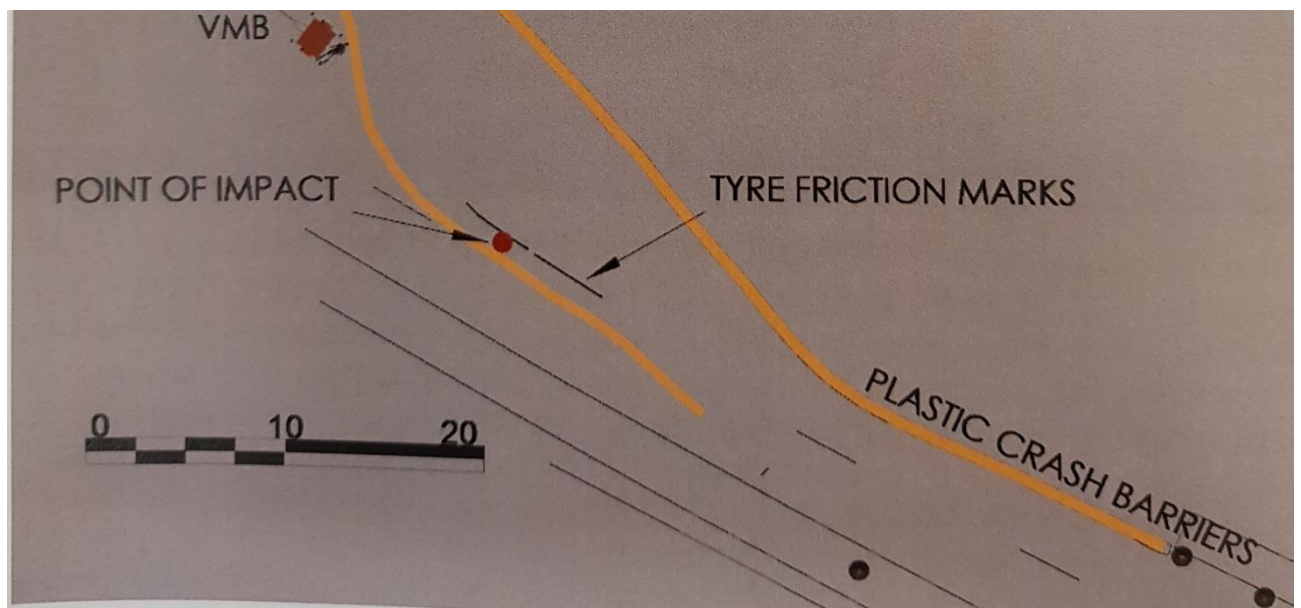
Diagram 4 showing the crash barriers after impact as well as tyre friction marks, position of the VMB (illuminated flashing arrow on trailer) and position where the deceased was located
