CITATION: *Inquest into the death of Daniel Thomas Bradshaw*  
[2018] NTLC 005

TITLE OF COURT: Coroners Court

**CATCHWORDS:** **Death of deckhand, dangerous access  
and egress from vessel, no gangway,  
regulatory response to death**

In the matter of an Inquest into the death of  
**DANIEL THOMAS BRADSHAW**  
**ON 8 JANUARY 2017**  
**AT BARGE EXPRESS**  
**25 MURAMATS ROAD, HUDSON CREEK**

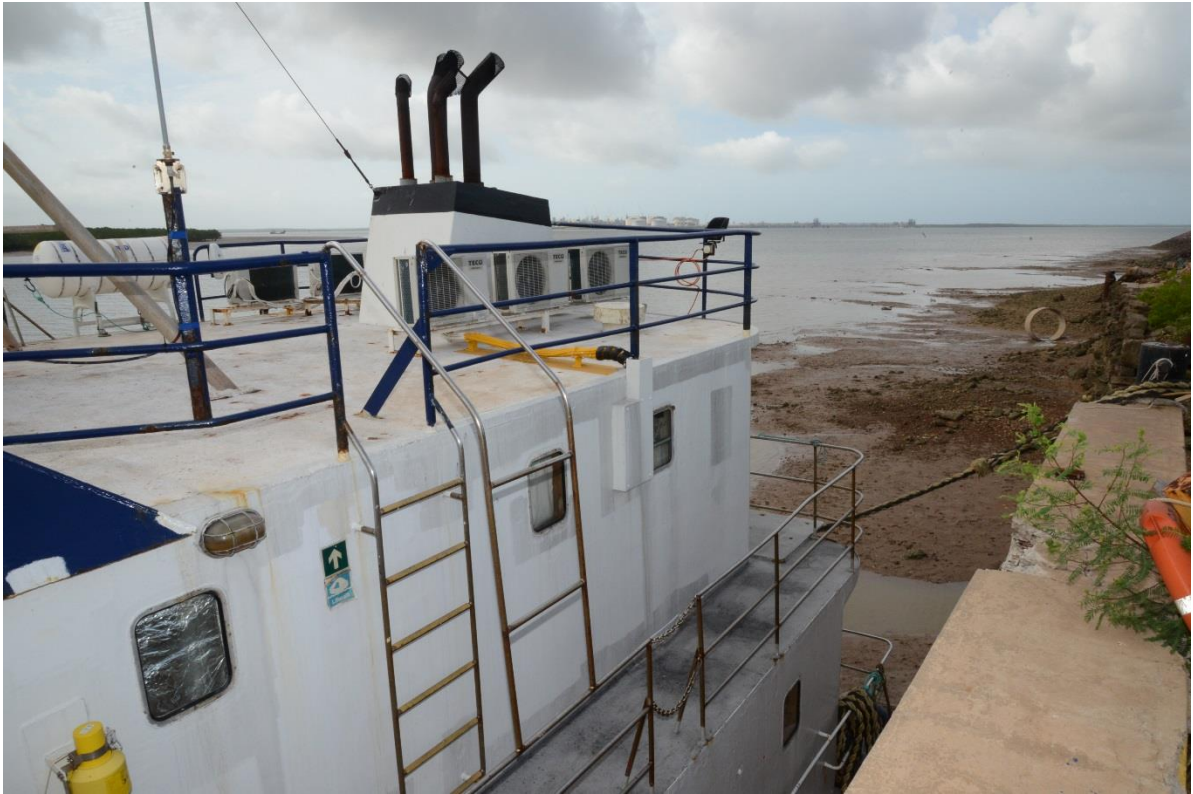
Photo 1 Showing the railing and ladder used for support while stepping from the barge to the wall.

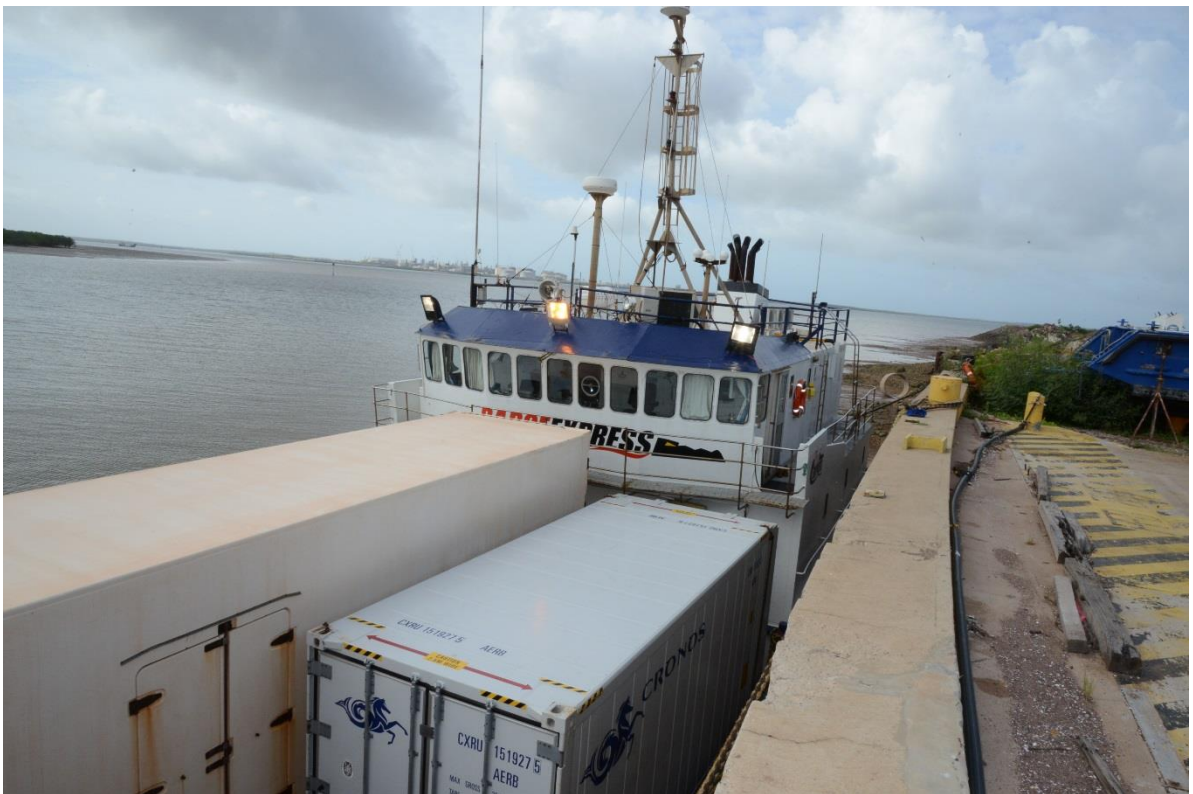
Photo 2 showing the railing and ladder in the distance.

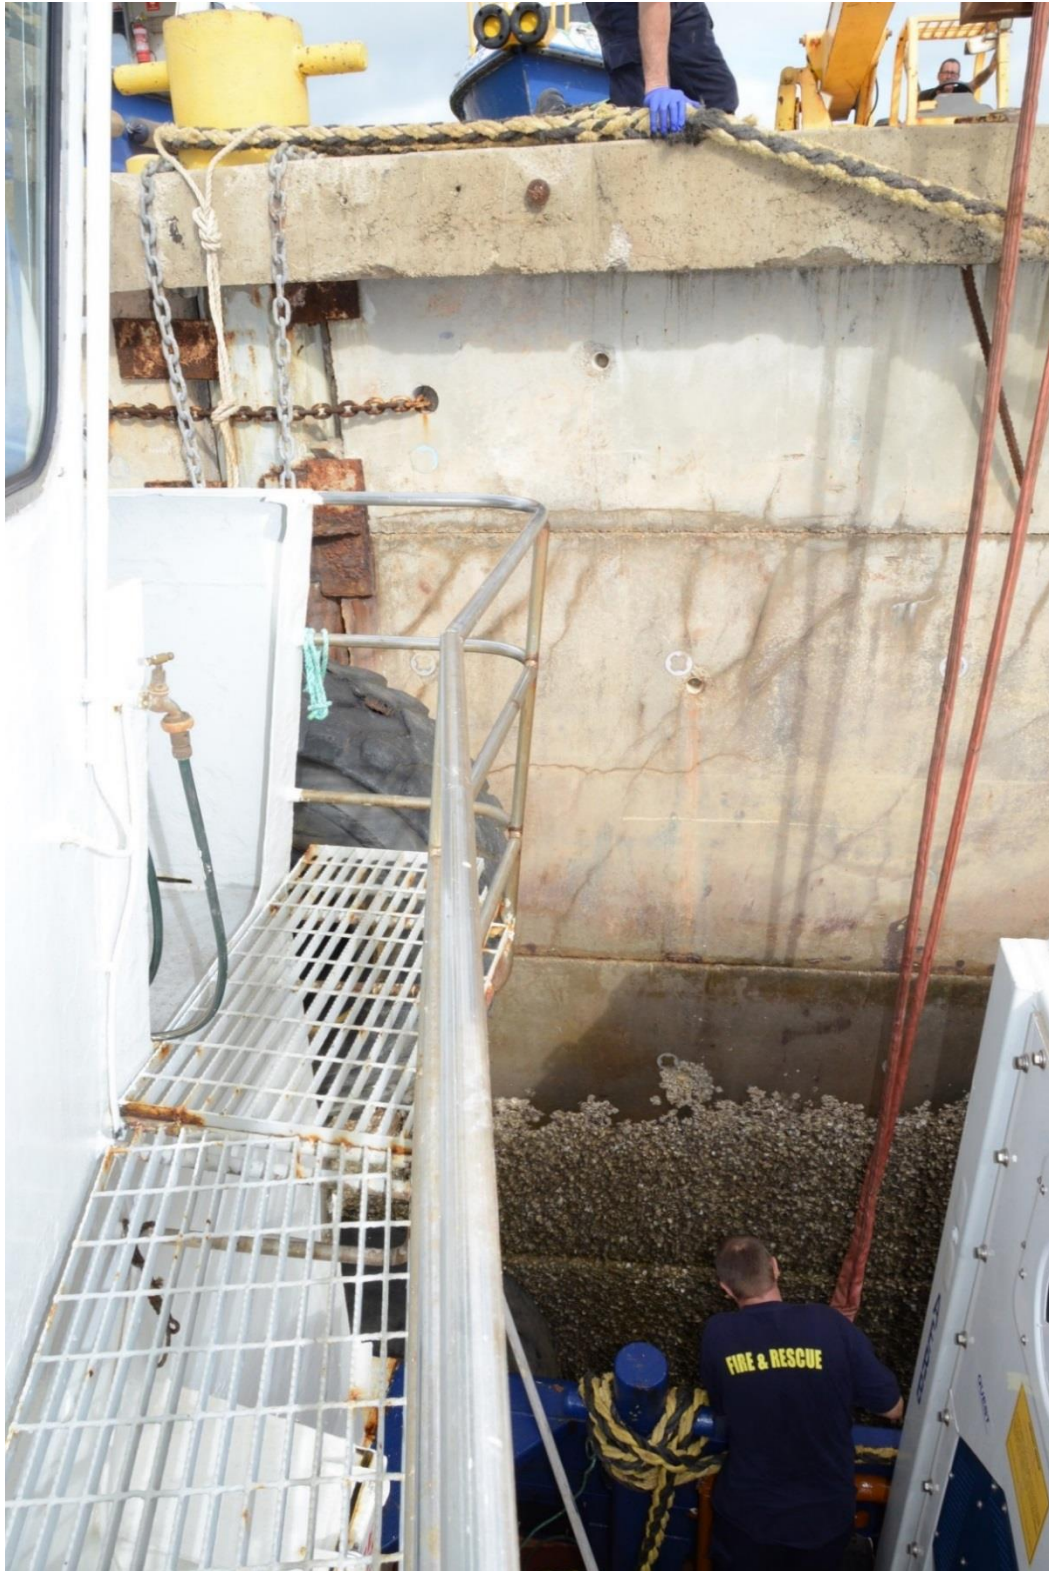
15. As the tide dropped however, that was not able to be done, and access and egress were gained by stepping onto a tyre on the wall and using the chains that held the tyre to get up and onto the wall.

Photo 3 showing the bridge wing, tyre and chains and the distance to the top of the wall

16. No one on the boat considered it necessary to put in place a gangway. That was despite the Safety Management Manual stating:

“When the ship is safely alongside, a gangway must be rigged in order to secure safe access to the ship. The gangway must be rigged with rail, safety net and appropriate lighting.”

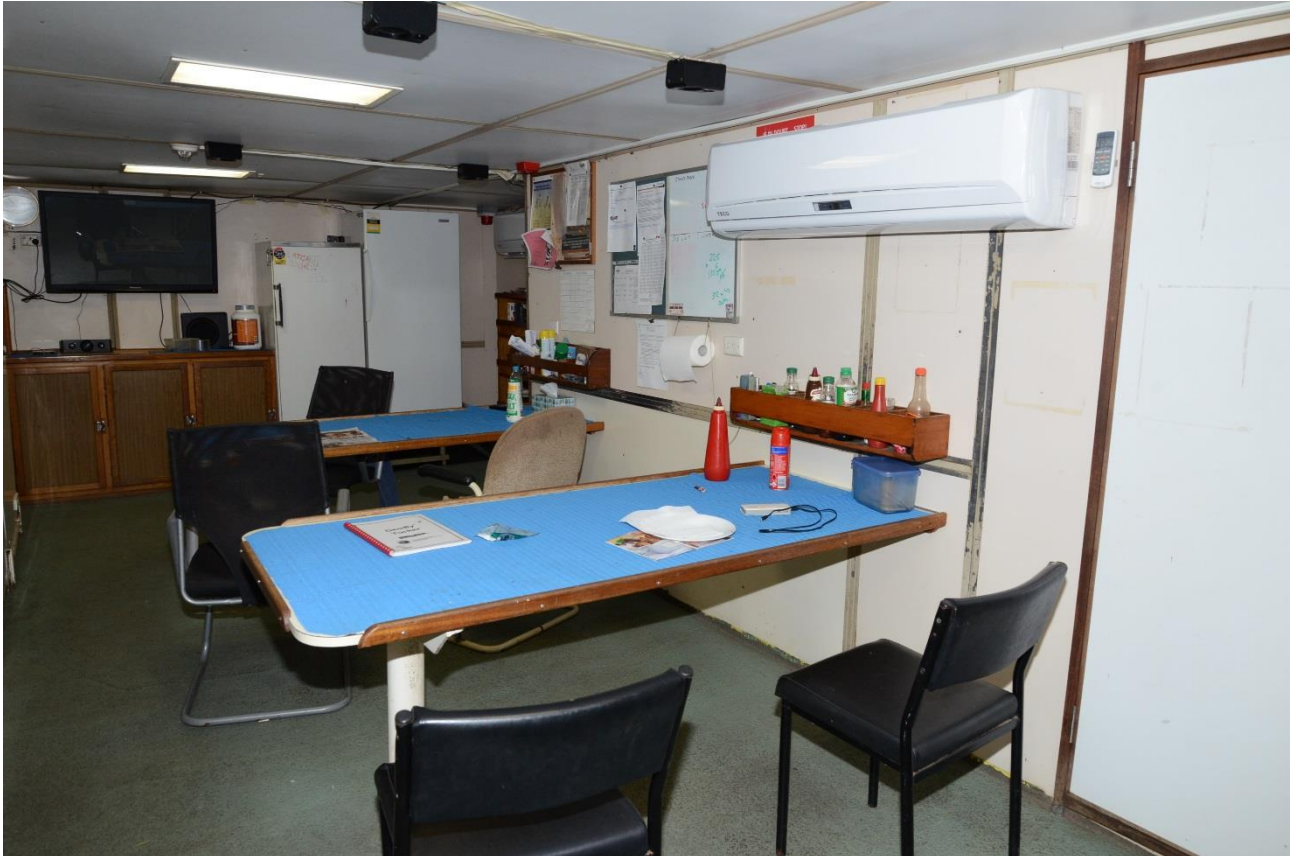
Photo 4 of galley showing plate at position where Dan sat and portable phone charger and cord

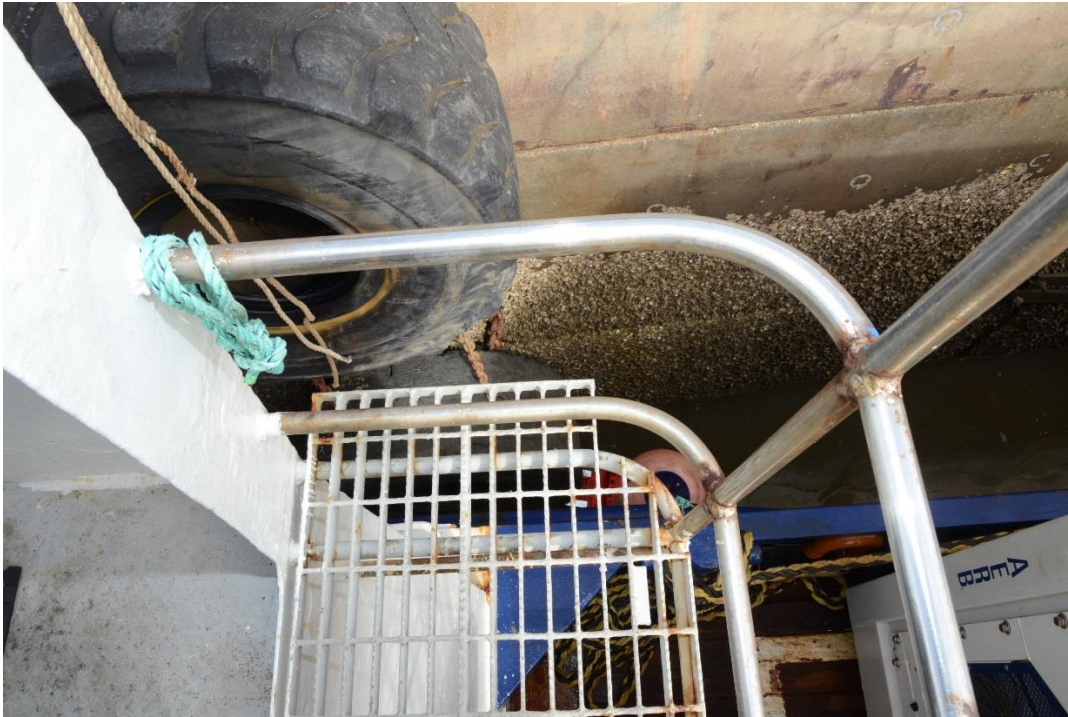
32. The laceration to the back of his head was in the opinion of Dr Rutherford due to a sharp edge rather than blunt trauma. The laceration travelled in an upward manner through the flesh to the skull.
33. The only sharp edge proximate to the location of his body likely to have been responsible for the laceration was the edge of the grated tread on the bridge wing.

Photo 5 showing edge of protruding bridge wing

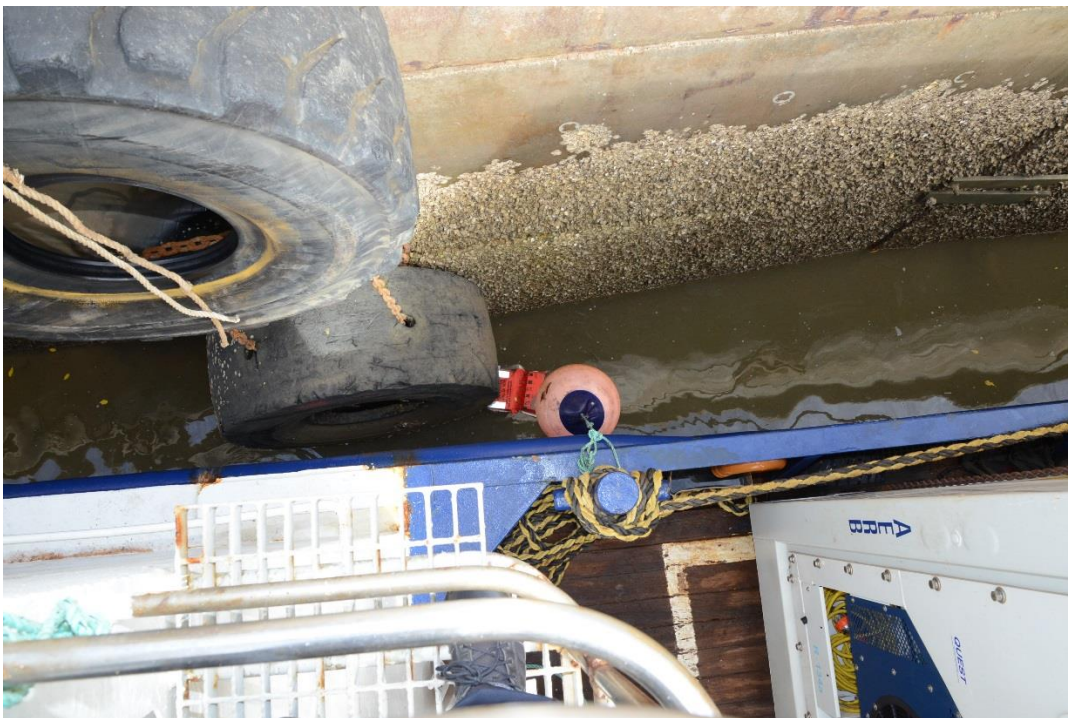
34. Below were the hard (albeit rounded) surfaces of the gunwales.

Photo 6 showing gunwale below bridge wing

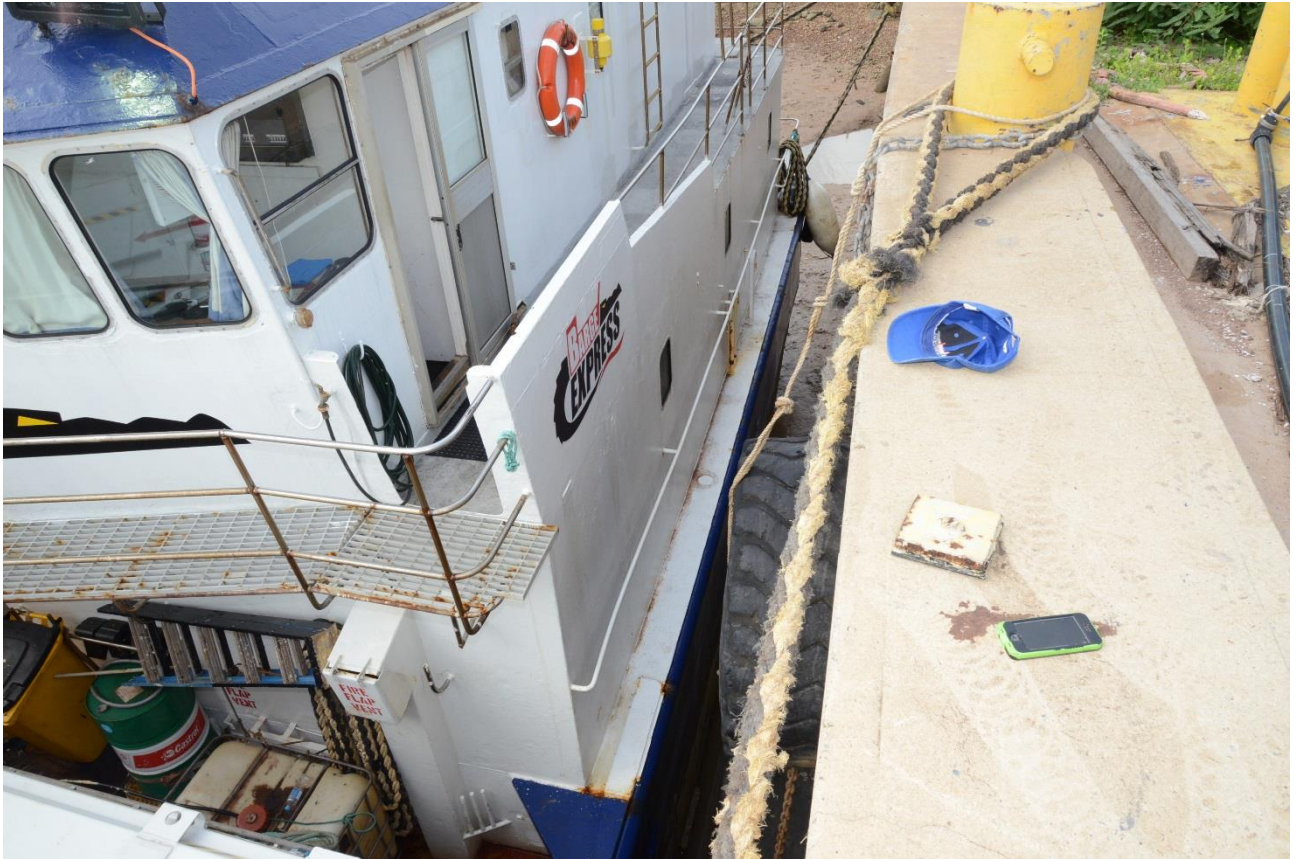
35. On the top of the Wall were Dan's mobile phone and cap.

Photo 7 showing Dan's cap and mobile phone on the top of the wall (the stain under the phone is rust and the tile nearby is fixed).

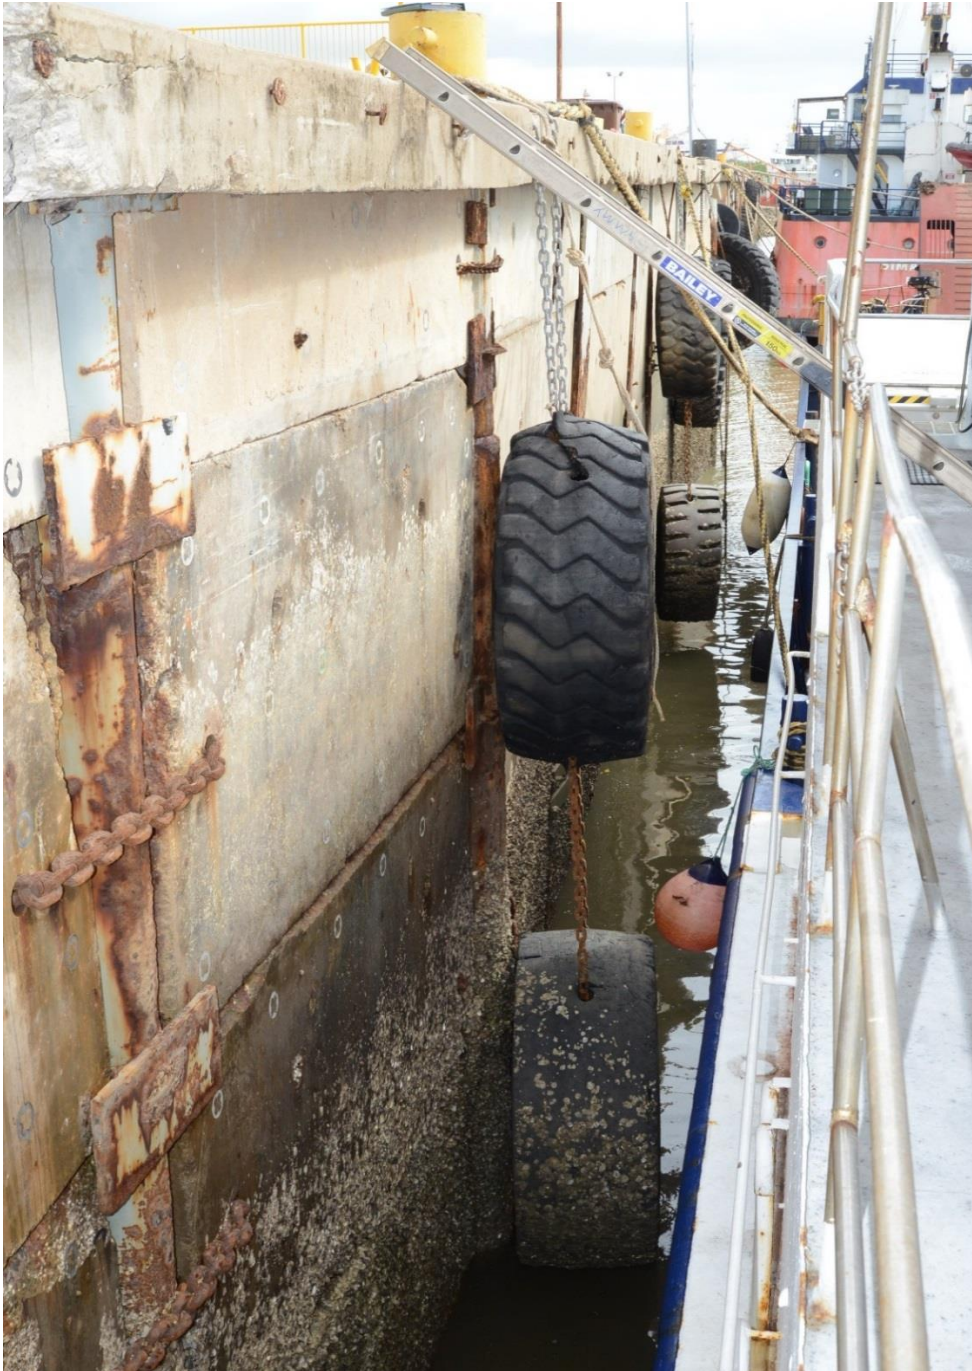
Photo 8 - Exhibit 5 depicting the means of access (minus the ladder)

67. The ladder in the photograph was put in that position after the death to allow access for the police officers undertaking the forensic analysis on the vessel. Why no gangway was used is likely because there was no suitable gangway.

68. I asked both the manager of Barge Express and Mr Hemming whether what that photo depicted was a safe means of access. They both agreed that it was not.

**Coroner:** Well, not only is that method shown by that photograph unsafe, surely it's dangerous as well isn't it?

**Mr Hemming:** I would agree that it does appear to be dangerous.”

1. All staff are prohibited to access or egress a vessel once it is safely moored, if no compliant gangway or bow door arrangement is in place. No Gangway/bow door arrangement – No Access/Egress.
