CITATION: *Inquest into the deaths of Robin Riley, Thomas Turpin, Fabian Andrews and Cassandra Martin [2019] NTLC023*

**CATCHWORDS:** **Single vehicle rollover, Kakadu Highway, gravel on bitumen at intersection with unsealed road**

In the matter of an Inquest into the deaths of  
**ROBIN RILEY, THOMAS TURPIN,  
FABIAN ANDREWS AND CASSANDRA  
MARTIN**

**AT: Kakadu Highway near the intersection  
with Bukbukluk Road**

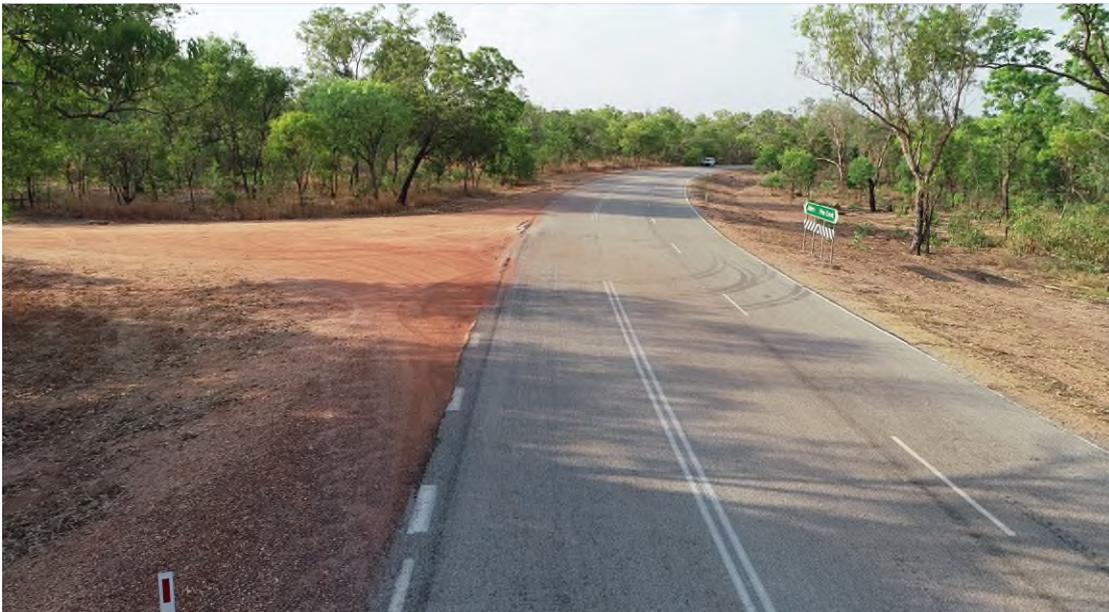
The intersection of Kakadu Highway and Bukbukluk Lookout Road (travelling north).

30. On the edge of the Highway surface at the intersection with the side road going to Bukbukluk Lookout gravel was deposited onto the Highway surface. Police calculated that the gravel on the road surface reduced the friction by about one third (0.690g to 0.432g).

54. I recommend that the Department of Infrastructure, Planning and Logistics ensure that removing gravel from sealed surfaces is added to the schedule of maintenance items.
55. I recommend that the Department of Infrastructure, Planning and Logistics ensure that an apron is installed as soon as possible on the road to Bukbukluk Lookout to prevent gravel from being deposited on the Kakadu Highway.

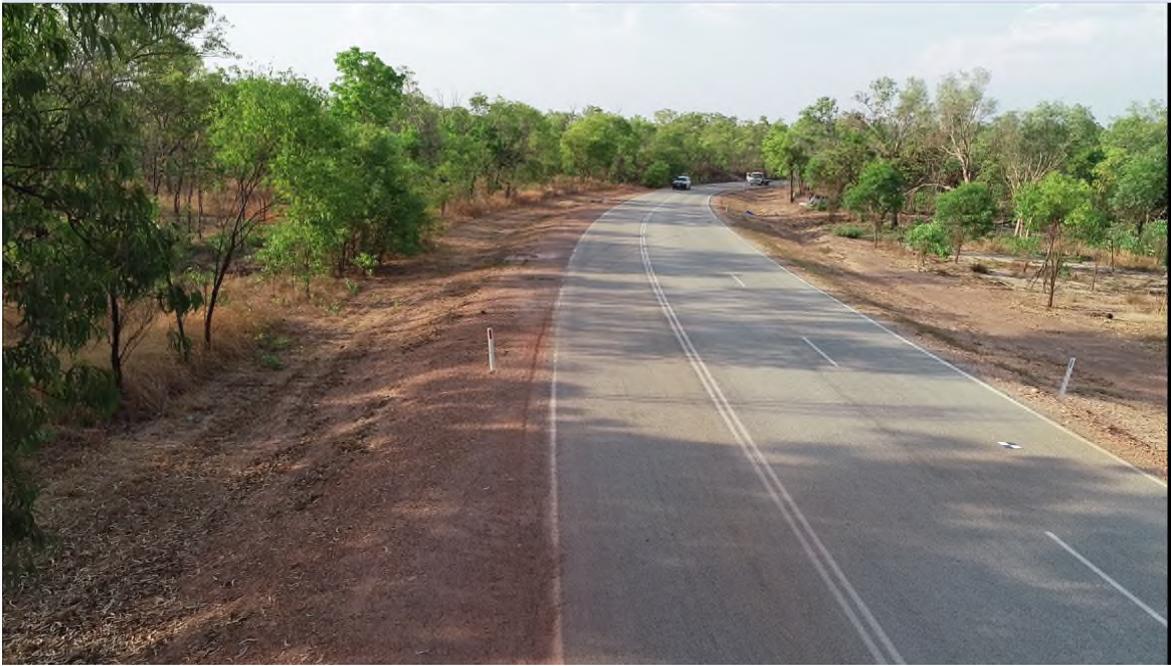
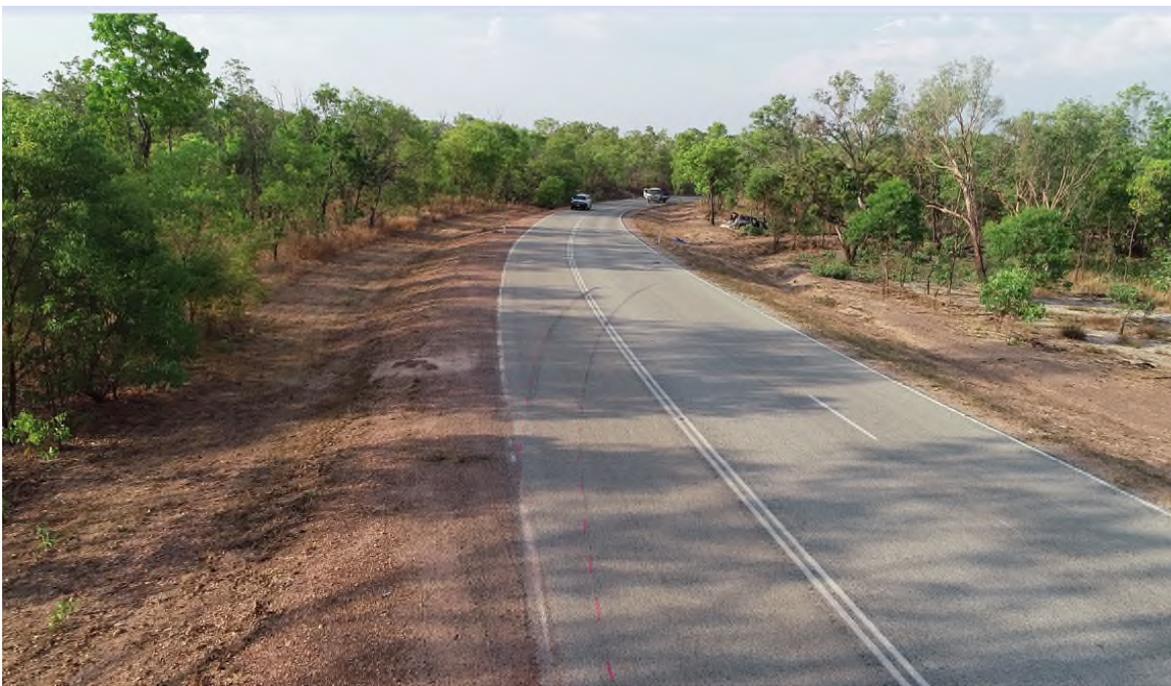
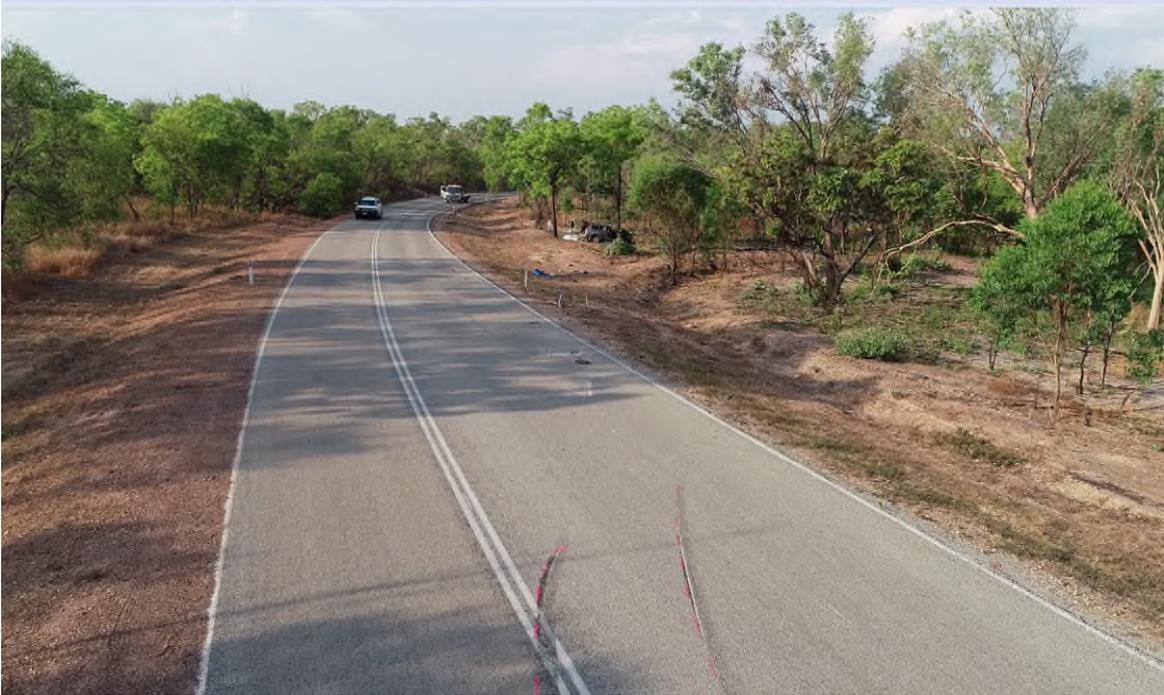
32. In approaching the curve Mr Riley did not take the optimal line. His outside wheels were close to the edge of the bitumen surface. In the opinion of the investigators the X-Trail vehicle began to slide while still on the bitumen surface. The left hand side wheels then left the sealed surface and travelled along the gravel shoulder until the vehicle went into a clockwise yaw and crossed the Highway before tripping while still on the bitumen and rolling.

33. The path of the vehicle as it went into the yaw and its final position can be seen in the following photographs.

“Steering commenced while the vehicle was still on the sealed surface, however due to the lower friction from loose gravel the vehicle entered a critical speed yaw. It is possible to negotiate the curve at 110 km/h with a peak lateral acceleration of 0.303 following the constant curve. If you did not follow a constant curve you would exceed 0.303 and with a friction supply of 0.4, it is not leaving much room for driver error.
