CITATION: *Inquest into the deaths of Robin Riley, Thomas Turpin, Fabian Andrews and Cassandra Martin* [2019] NTLC 23

CATCHWORDS: **Single vehicle rollover, Kakadu Highway, gravel on bitumen at intersection with unsealed road**

**AT: Kakadu Highway near the intersection
with Bukbukluk Road**

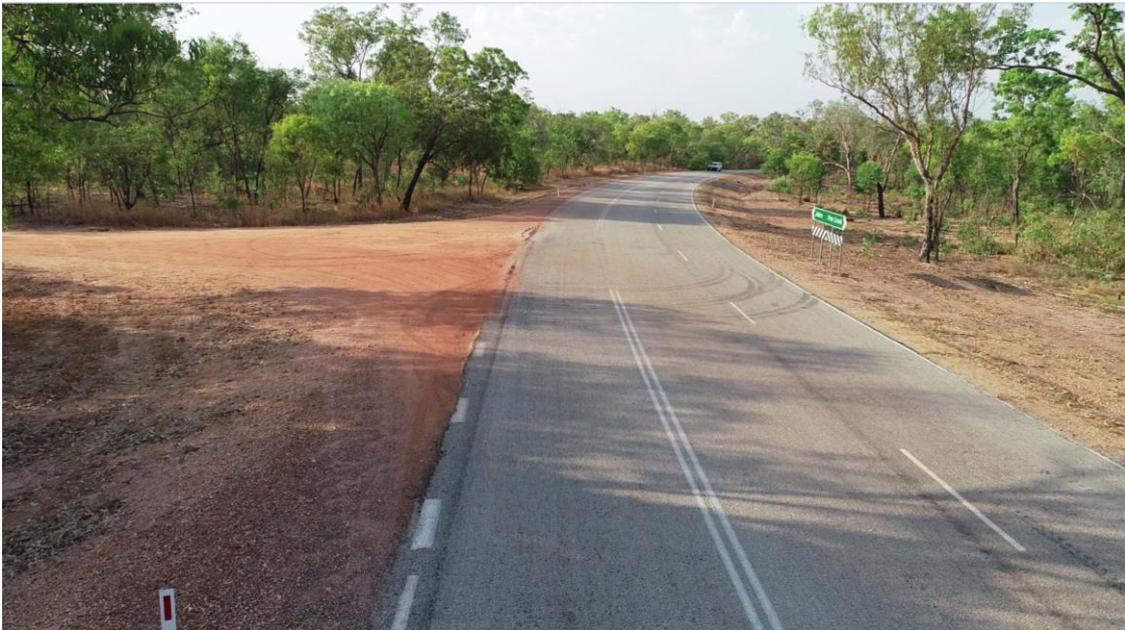
24. It is one of the two entrances to the Kakadu National Park, an area with a world heritage listing for its natural and cultural significance. It is however a road that receives a relatively low volume of traffic. There is an average of 370 vehicles per day that travel the Highway at the northern end and less than 150 vehicles per day at the southern end. Those numbers hit a peak in the months of July and August with 750 vehicles in the north and 330 vehicles in the south using the road.
25. Seventy-six kilometres from the southern end is a turnoff to Bukbukluk Lookout where the crash occurred.

The intersection of Kakadu Highway and Bukbukluk Lookout Road (travelling north).

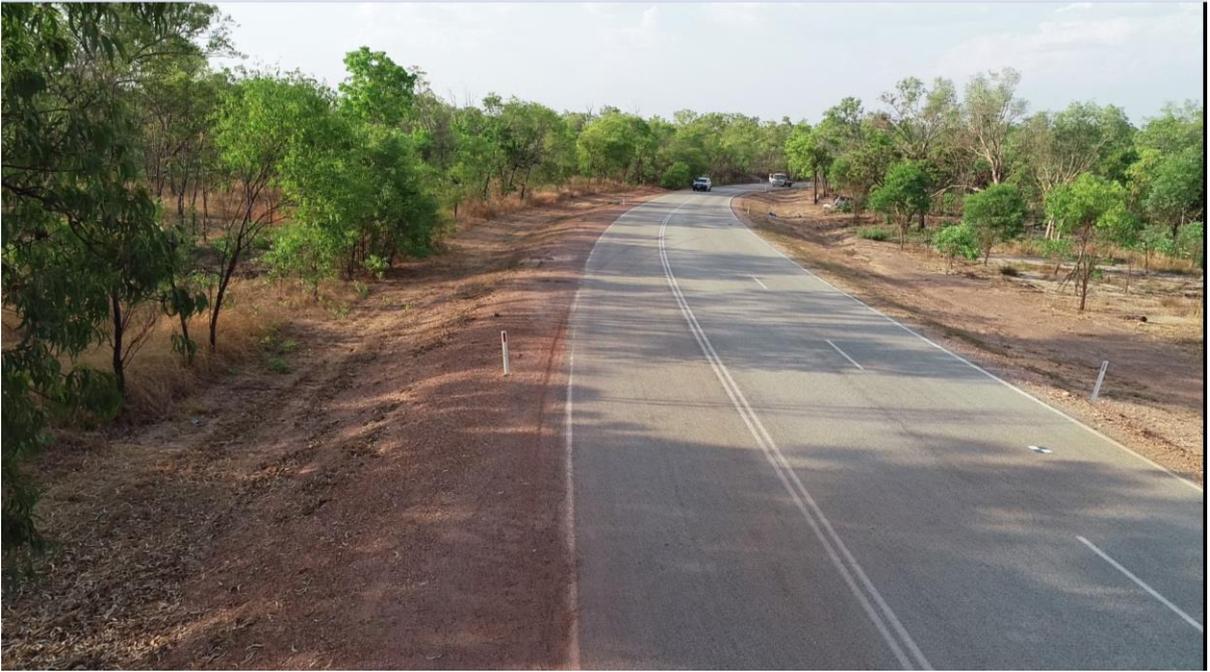
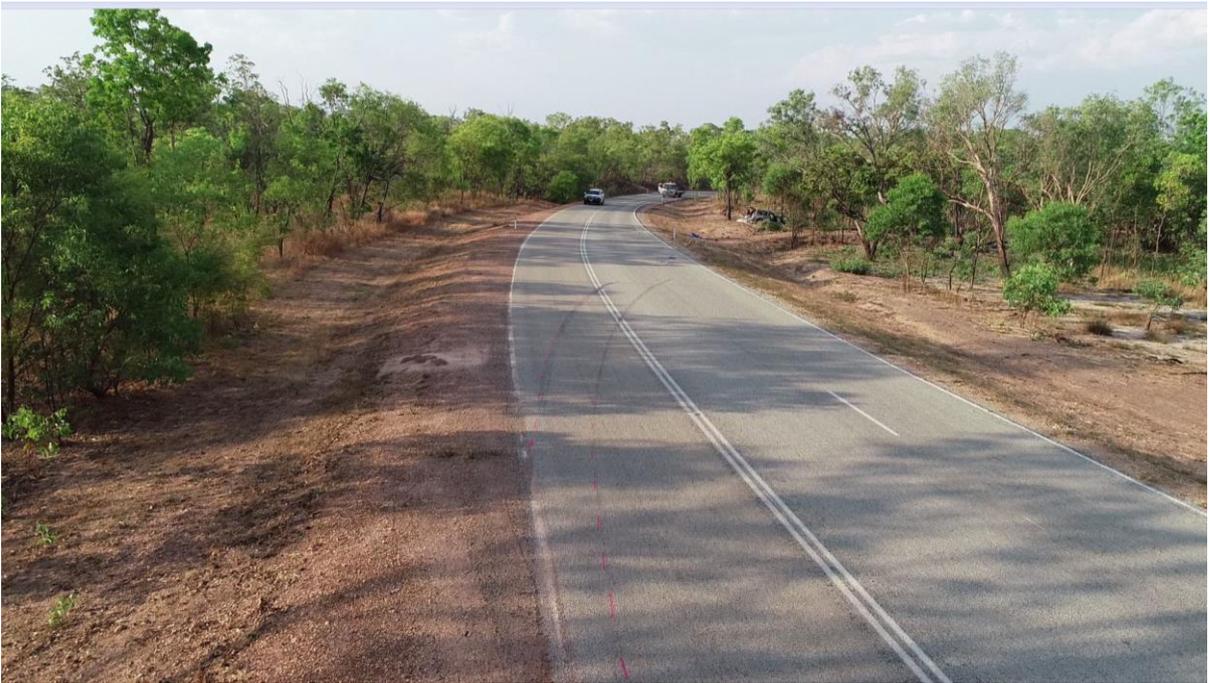
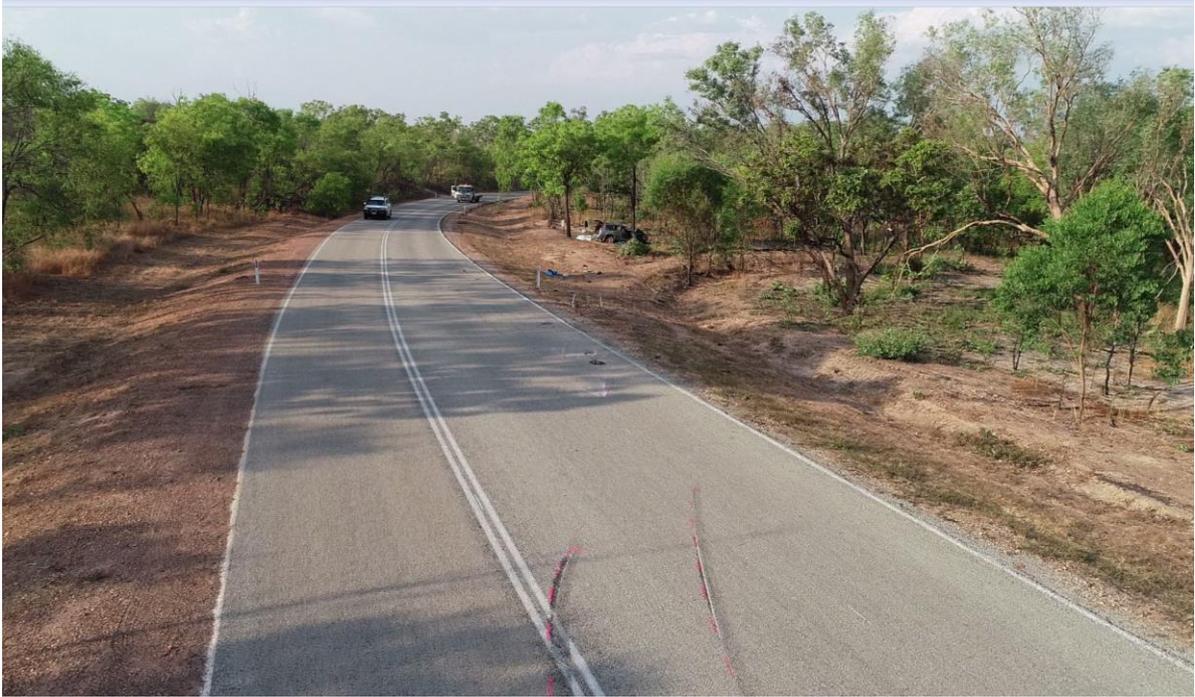
30. On the edge of the Highway surface at the intersection with the side road going to Bukbukluk Lookout gravel was deposited onto the Highway surface. Police calculated that the gravel on the road surface reduced the friction by about one third (0.690g to 0.432g).

32. In approaching the curve Mr Riley did not take the optimal line. His outside wheels were close to the edge of the bitumen surface. In the opinion of the investigators the X-Trail vehicle began to slide while still on the bitumen surface. The left hand side wheels then left the sealed surface and travelled along the gravel shoulder until the vehicle went into a clockwise yaw and crossed the Highway before tripping while still on the bitumen and rolling.

33. The path of the vehicle as it went into the yaw and its final position can be seen in the following photographs.

37. The second draft was provided to Police Investigators on 19 February 2019. It identified 1250 areas where improvements were recommended. It set out a risk assessment in relation to all substandard areas. In relation to the curve and intersection where the crash happened the auditors rated the risk at the highest category, “Intolerable” and recommended that the risk would be mitigated by putting a sealed apron on the Bukbukluk Road so that the gravel would not be deposited onto the Highway.

54. I recommend that the Department of Infrastructure, Planning and Logistics ensure that removing gravel from sealed surfaces is added to the schedule of maintenance items.
55. I recommend that the Department of Infrastructure, Planning and Logistics ensure that an apron is installed as soon as possible on the road to Bukbukluk Lookout to prevent gravel from being deposited on the Kakadu Highway.
