CITATION: *Inquest into the death of Peter John Bonnell*
[2018] NTLC 002

CATCHWORDS: **Collision by motorcycle rider with temporary traffic control devices, rider impairment, failure to install traffic control devices in accordance with Australian Standard, report to DPP**

PETER JOHN BONNELL
ON 30 APRIL 2016
AT TIGER BRENNAN DRIVE

FINDINGS

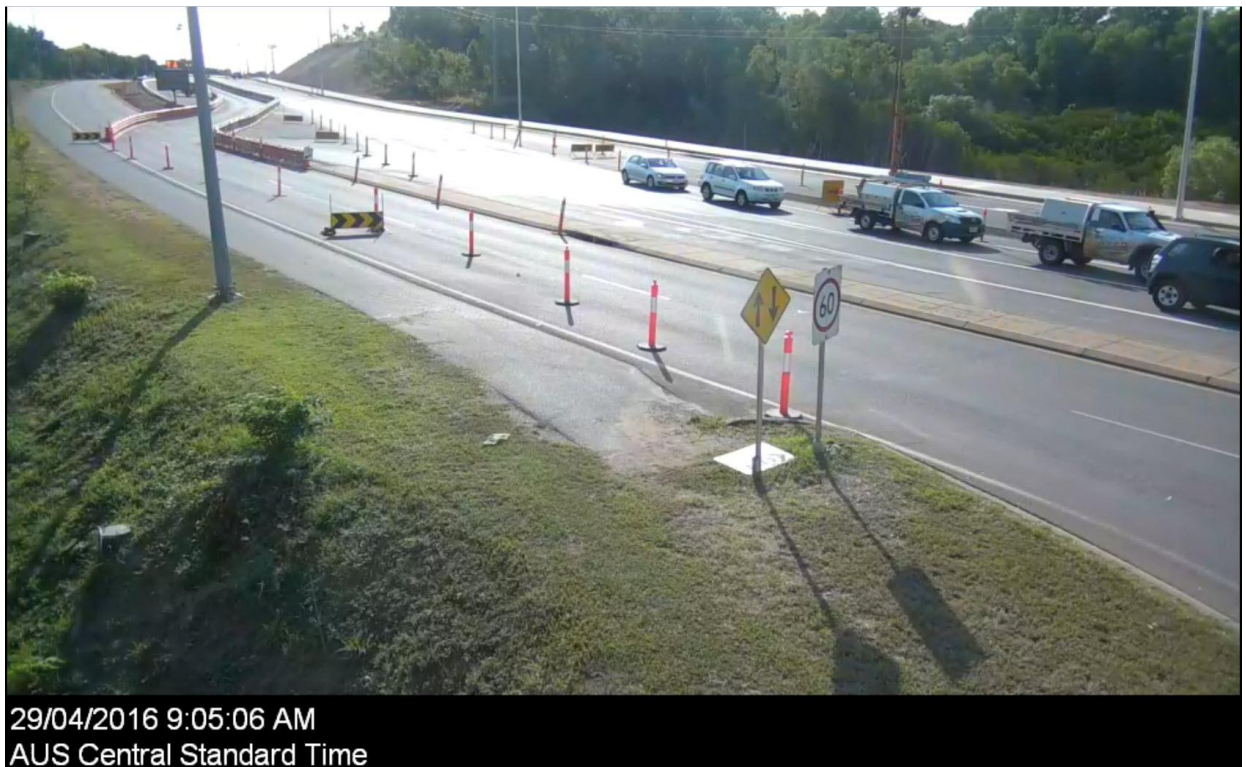
76. It is not known how that happened. The movement of the barriers was not known to BMD or DIPL and there appears to be no record of that being noticed during any inspection and audit. It is however likely that the movement occurred due to the barrier being hit by a vehicle.
77. Four days later correction was made. There is no note of who put the barriers back into alignment. DIPL and BMD said they had no knowledge of that either.

78. After the deceased struck the barriers they were pushed out of alignment again, as depicted in the photograph below.
