CITATION: *Inquest into the death of Xavier Nicholas Lengyel*  
[2019] NTLC 005

**CATCHWORDS:** **Traffic collision between unregistered motorcycle and vehicle, substandard police investigation, referral back to Police and DPP**

**XAVIER NICHOLAS LENGYEL**  
**ON 14 MARCH 2018**  
**AT LEONINO ROAD, DARWIN RIVER**

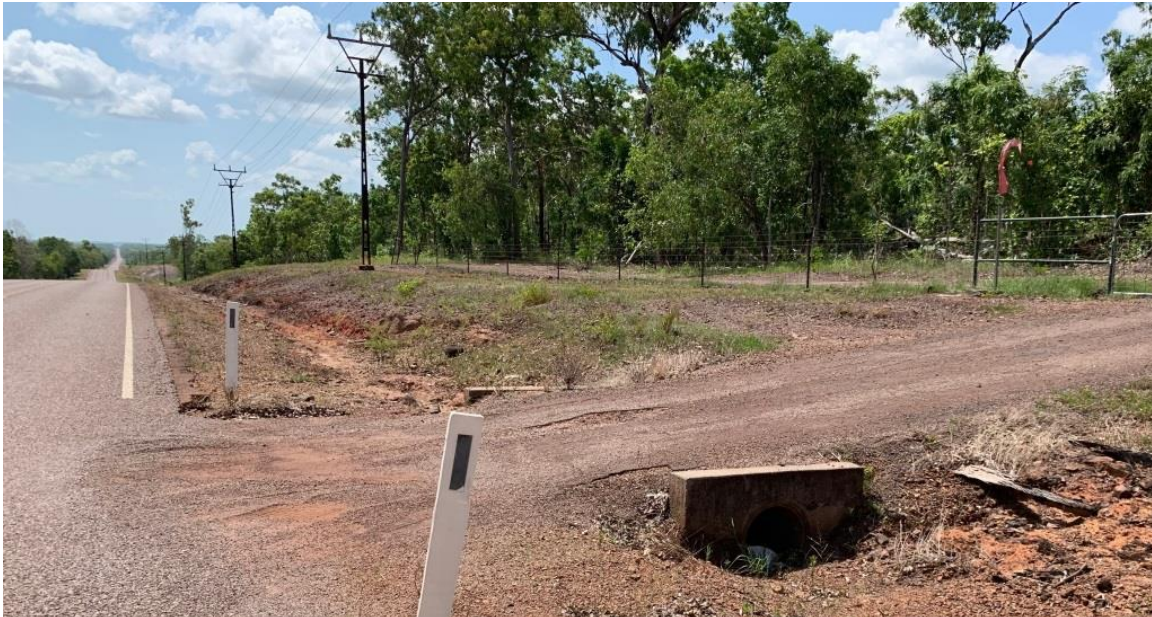
Image 1 - Leonino Road from the driveway of the family of the deceased, looking west

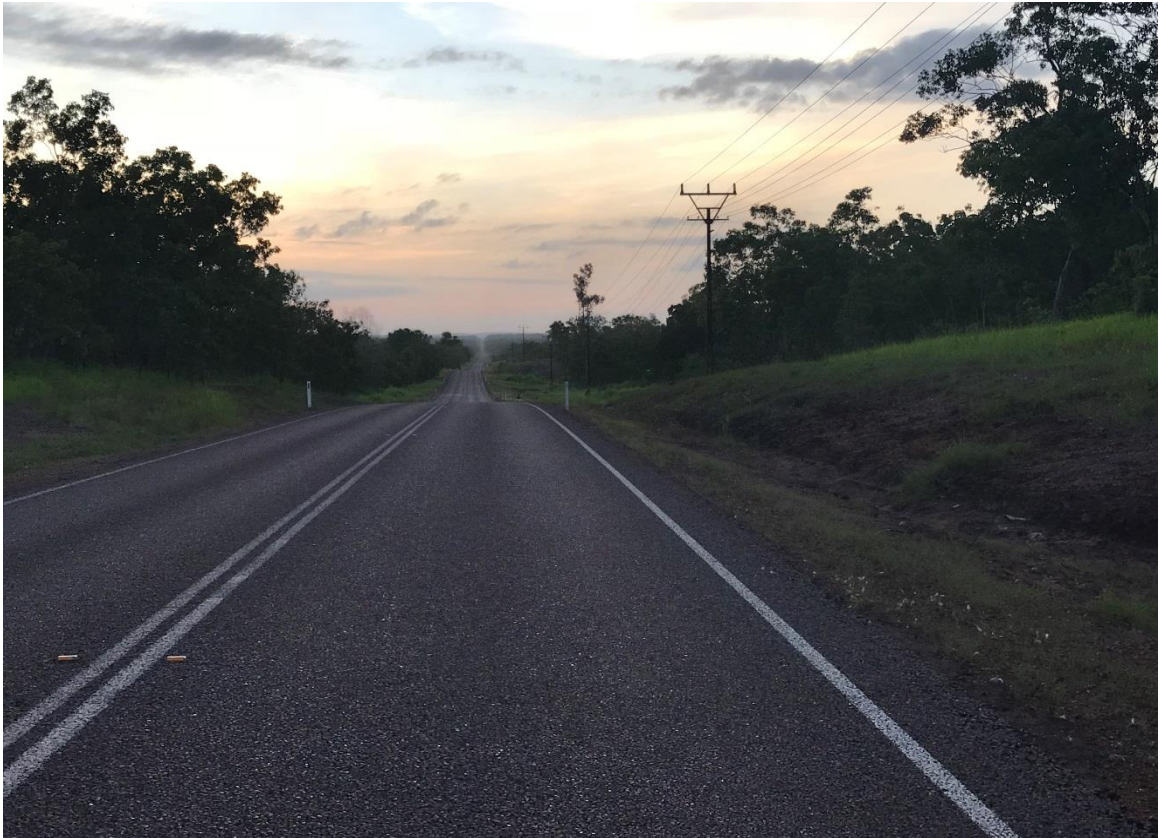
Image 2 - looking west down Leonino Road in the late afternoon

9. Xavier was about 200 metres from the driveway of his residence. He was riding in a easterly direction up the hill. There were double white lines down the middle of the roadway.

42. That view omitted to take into account that, as readily seen from the photographs, there is a second crest that obscures visibility from the top of the hill.

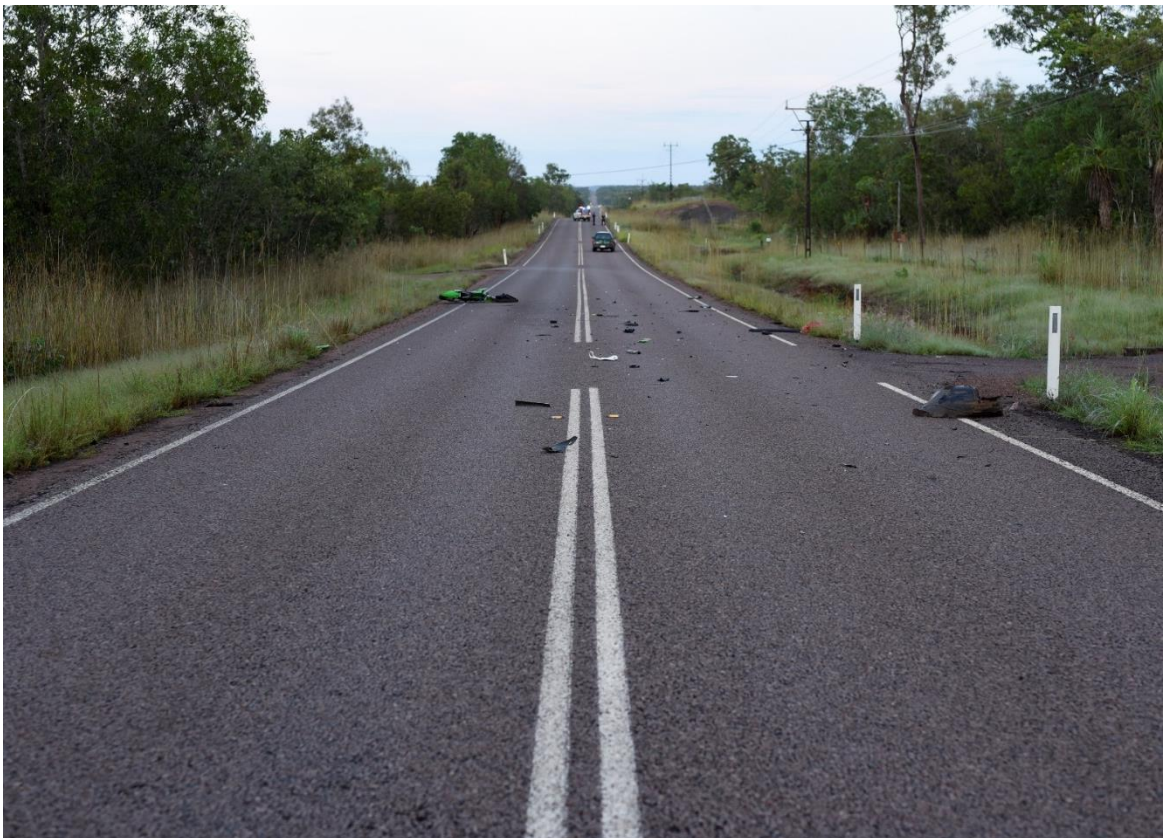
Image 3 - scene of collision

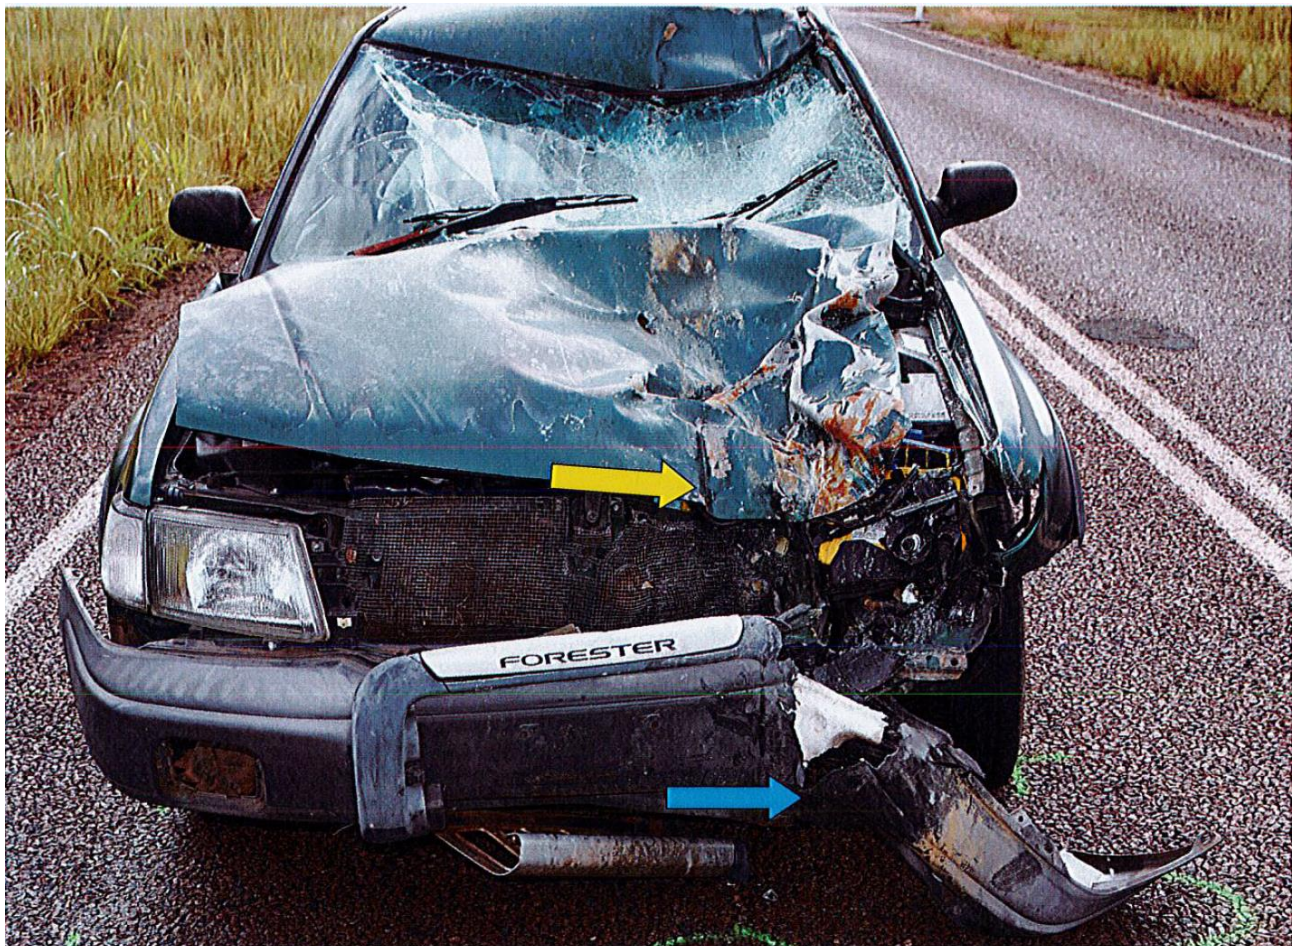
Image 4 - Image and explanation from Police Crash Report.

36. Examination of the motorcycle confirmed to investigators that it had not been doing a wheel stand at the time of impact. There was extensive damage to the front wheel and forks. The Subaru also had an impression in the front bonnet from the motorcycle front fork and damage to the bumper bar considered by investigators to be caused by the motorcycle front wheel.

Image 1 - Yellow arrow indicates impression in bonnet from motorcycle front fork.  
Blue arrow indicates damage caused by motorcycle front wheel

56. If the crash investigators are correct in their opinion that the front wheel of the motorcycle was on the ground at the point of impact, it is difficult to accept the estimates of the very short distances and time involved between seeing the motorcycle and impact and the version that Xavier was riding on the back wheel. There are three reasonably available scenarios:

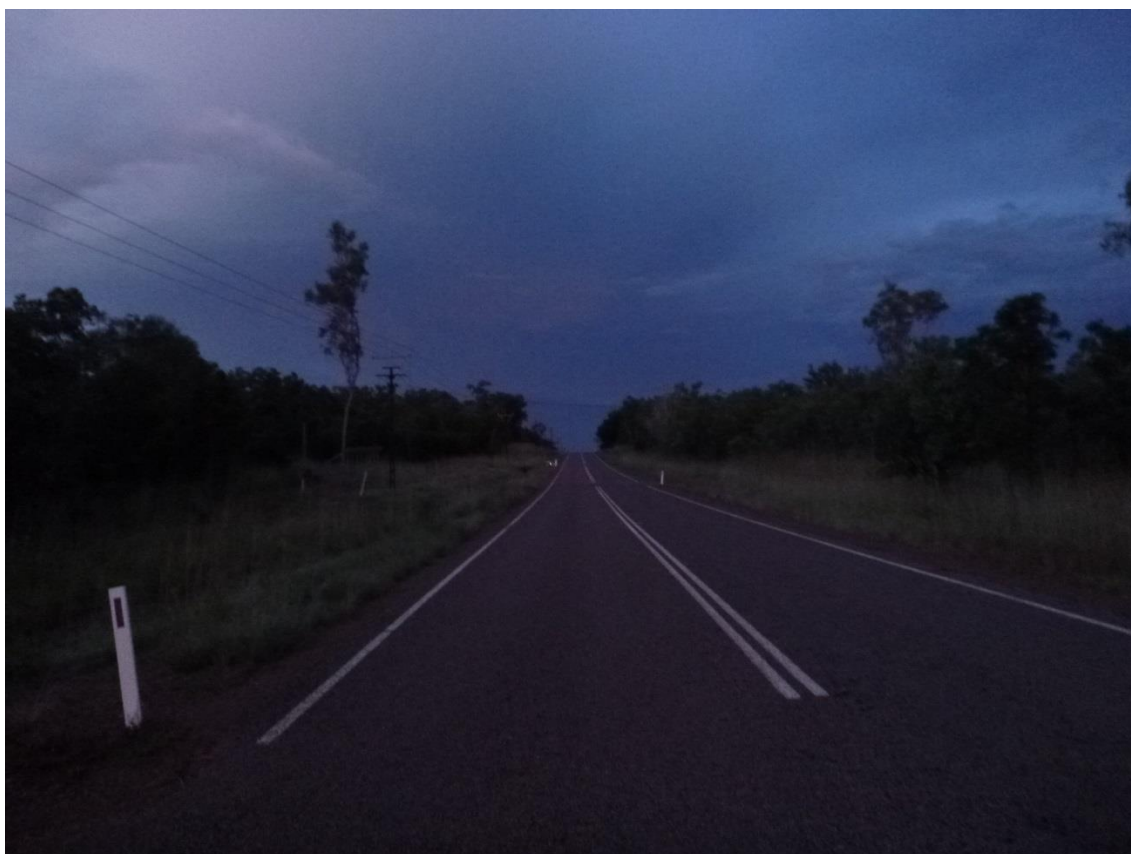
50. During the course of the Inquest the young man said that the level of light was similar to the following photograph.

Image 5 – looking up road from about where the Subaru stopped after the collision to the top of the hill
